# Audit of Prince of Wales Road westbound cycle track

Camden Cycling Campaign November 2020

## Snagging list - ordered from east to west

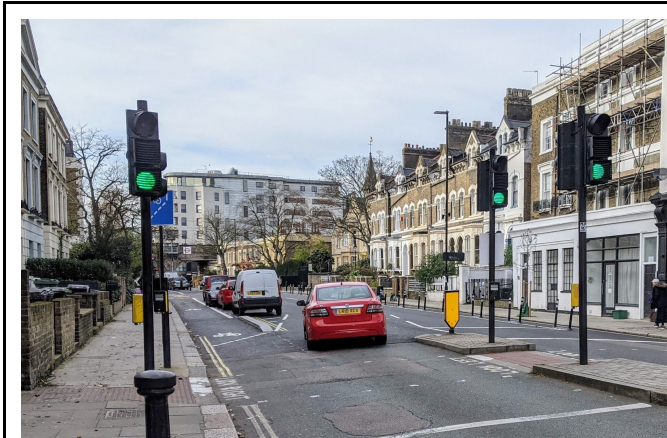
Approach from east: There is a pinch point (caused by a traffic island) just before the start of the cycle lane at Grafton Road/Castlehaven Road junction. [Figure 1](#). We suggest installing bollards just after the island and possibly modifying or removing the island.

Figure 1. Looking west from junction Grafton Road: pinch point between island and cycle track.

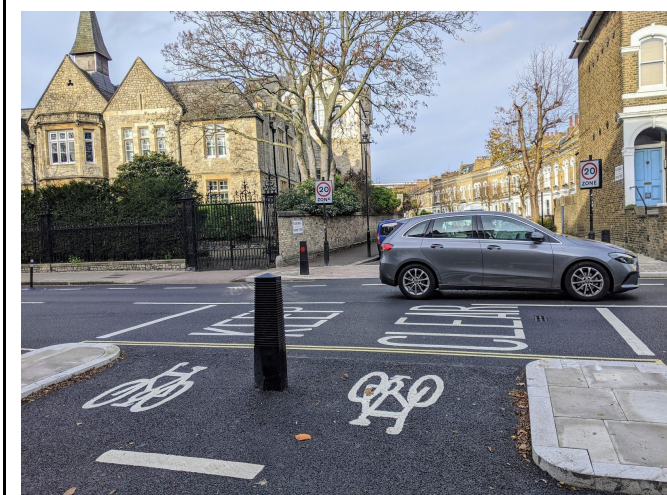
Access to the westbound lane from Ryland Road will be an important connection if there is no right turn out of Grafton Road. See [Figure 2](#). The entry and exit point is well designed for this purpose. We suggest adding another "KEEP CLEAR" on the eastbound motor lane (as in the westbound lane) as queues may form in this location.

Figure 2. Access to and from to Ryland Road. The KEEP CLEAR allows access in and out of the westbound cycle lane. As eastbound queues sometimes form here, it would be useful to have a KEEP CLEAR in both directions.

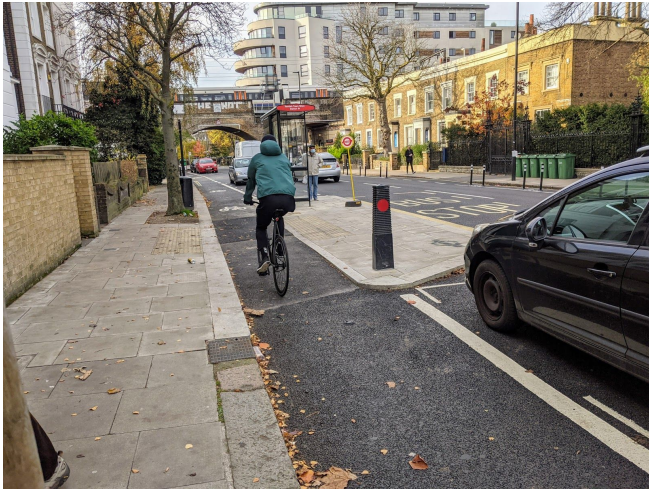
The bus stop near Hadley Street lacks zebra and other markings. See [Figure 3](#).

Figure 3. Bus stop near Hadley Street. Needs zebra and other markings.

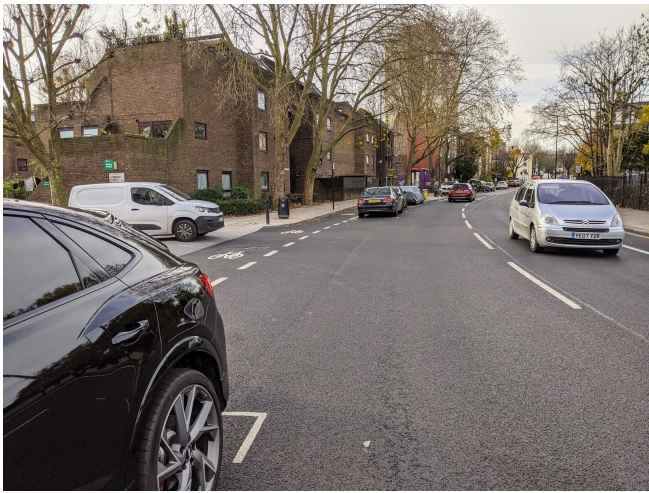
[Figure 4](#) shows the junction at Harmood Street as viewed by a westbound driver. There have already been several reports of conflicts between cyclists or pedestrians and motor vehicles including [this letter in the CNJ](#).

There are no DYL markings and those specified on [the TMO drawing](#) are too short (~5m and ~4m). Parking bays need to be cut back here. In addition the cycle track needs more emphasis than just the logos.

Figure 4. Junction of Harmood Street as viewed by a westbound driver who can't see approaching cycles

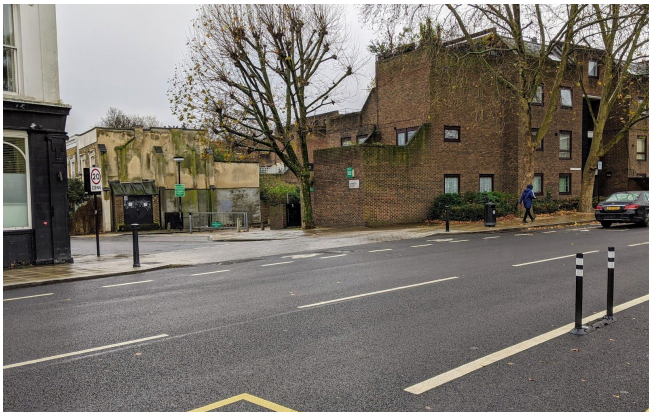
[Figure 5](#) shows the junction of Harmood Street from the other side of PoW. The entrance is too wide and has flared corners which will encourage high speeds for motor vehicles. The corners should be tightened.

Figure 5. Junction of Harmood Street seen from the other side of PoW Road. Note that the dropped kerbs follow the original flared street entrance unlike others in PoW. e.g Ryland Road and Talacre Road (figures 2 and 6).

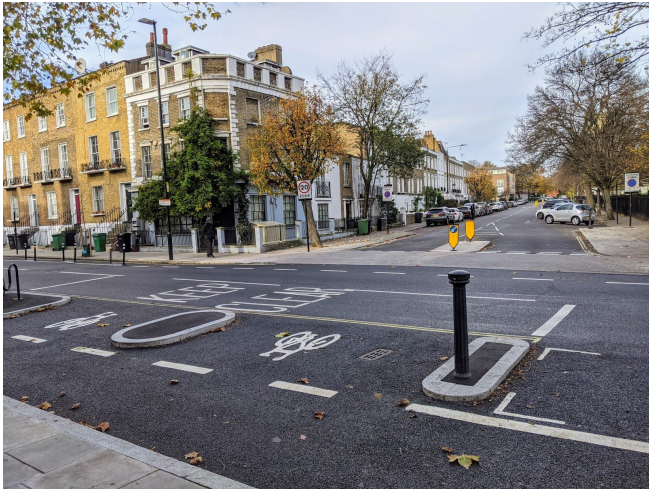
See [Figure 6](#). We have included this as an illustration of the very nice details of access between the westbound cycle lane and Talacre Road.

Figure 6. Talacre Roads junction. Very nice detailing.

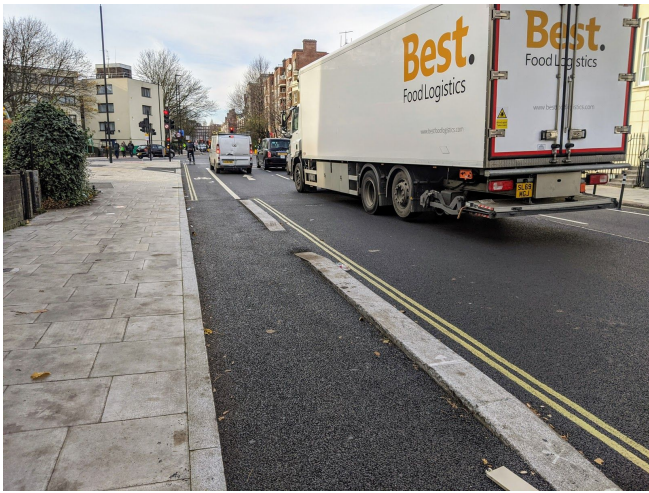
- On the Westbound approach to the Malden Road junction the cycle lane is protected with kerbs after the end of the motorcycle parking ([Figure 7](#)). But the last 10 metres (or so) are marked as a narrower ~1.5m mandatory lane where extra space in the carriageway is occupied by a right turn lane for motor traffic<sup>1</sup>. We observed many drivers coming over the mandatory lane; for better separation from motor vehicles, we suggest a line of bollards right up to the ASL box as at the Haverstock Hill junction shown in [Figure 8](#).

Figure 7. Westbound approach to Malden Road. The concrete kerbs stop short of the junction; after that the marked lane is unprotected and narrows down to about 1.5m.

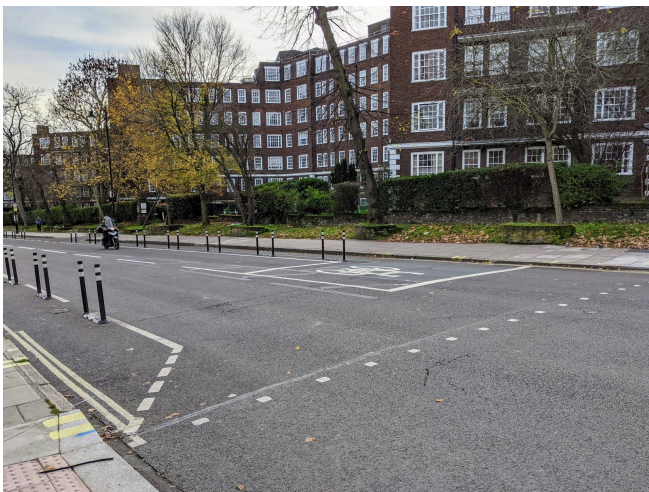
Figure 8. Haverstock Hill. Bollards go right up to ASL box

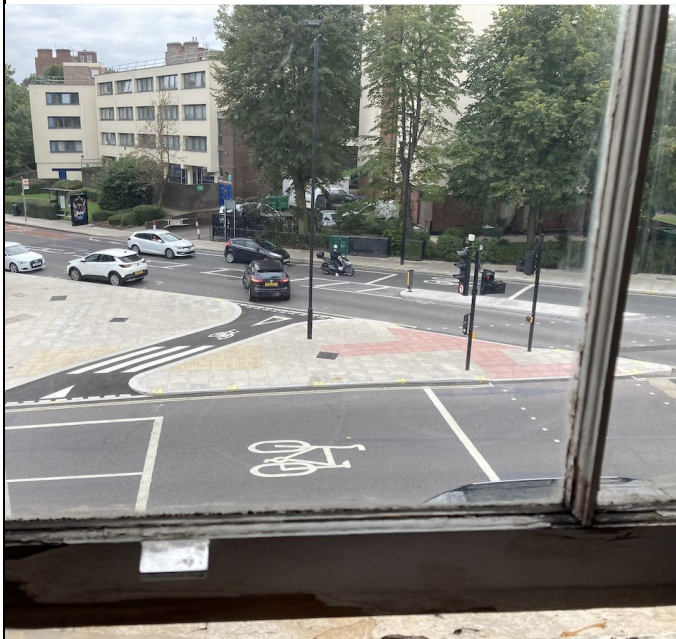
- Motor vehicles are using the cycle cut-through to access Malden Crescent as reported from someone who lives on Prince of Wales Road by the junction with Malden Crescent. See [Figure 9](#) and also see [this video of a van cutting through](#). These transgressions would be prevented by the line of bollards to the ASL suggested above.

Figure 9. Motor vehicle just used the cut through from PoW to Malden Crescent.

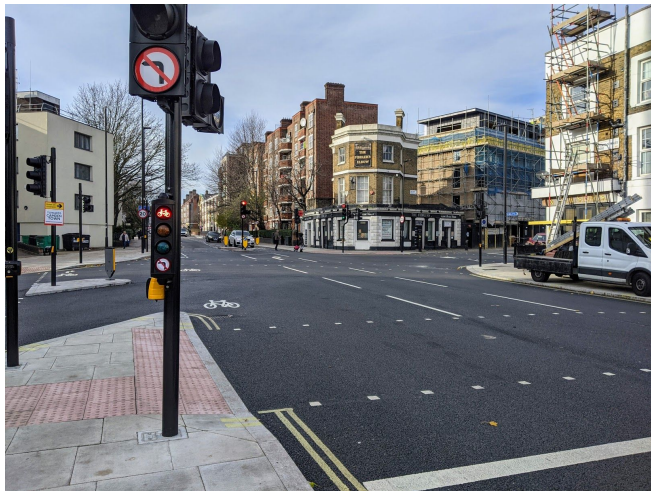
- The photo in [Figure 10](#) is a close up of the Malden Road junction showing the low-level lights and the two-stage right turn. We saw cyclists turning right from the right side of the ASL (where they couldn't see the early release signal) but didn't see anyone using the two-stage right - is there a way to point it out with signage?

Figure 10. Close up of Malden Road junction showing the low-level lights and the two-stage right turn

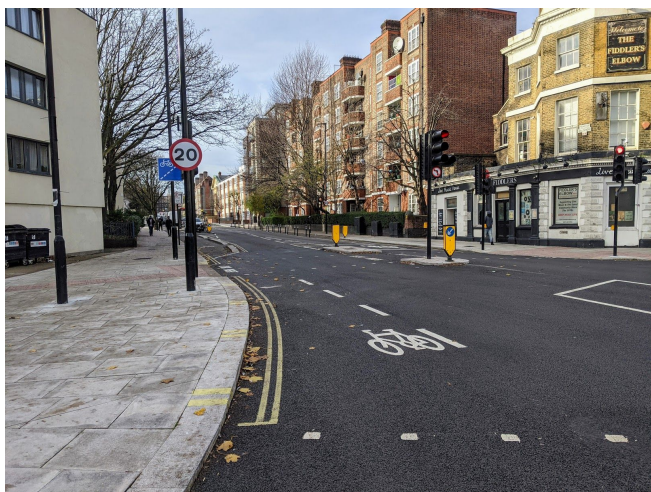
Figure 11. Western exit from Malden Road junction: advisory marking up to the pedestrian crossing and kerb protection immediately after

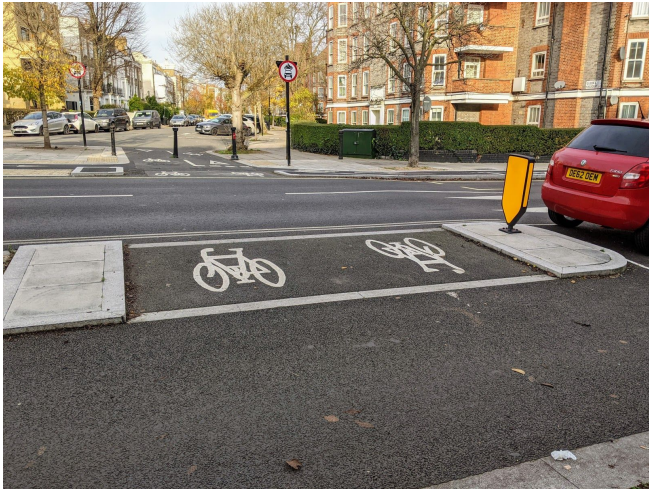
[Figure 12](#) shows how the westbound cycle lane is accessed from Queen's Crescent and vice-versa. The waiting spaces for cycles on both sides of the road are well-conceived. After a test ride we concluded that the junction is as good as it can be, with dedicated spaces for cycles to wait on both sides of PoW. However, the right turn into Queen's Crescent is very difficult when westbound motor traffic is queuing. We suggest a KEEP CLEAR on the westbound carriageway.

Figure 12. Queen's Crescent Junction. Waiting space for cyclists entering and leaving the cycle lane on both sides of the road

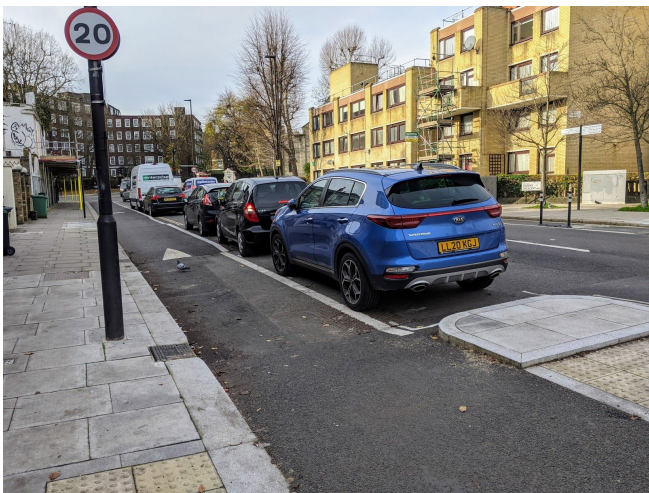
The cycle lane dips down and then up again between the table at the Queen's Crescent junction and the stepped track. See [Figure 13](#). We suggest filling it in but note that the pair of drains on the edge of the footway may make this impractical.

Figure 13: Cycle lane dips down and then up again.

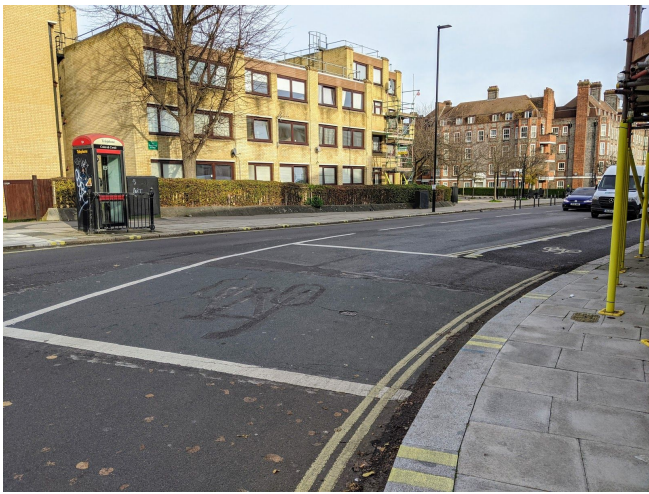
This has been improved by the addition of early release on all three arms. The approach on PoW is excellent with a stepped track right up to the ASL box. See [Figure 14](#).

There is a need to mark cycle logos in ASL boxes at Haverstock Hill junction on west and north arms (see [Figure 14](#))

Figure 14. Haverstock Hill junction. Stepped track reaches ASL box. ASL box needs logos
