# Review of cycling infrastructure around the Swiss Cottage Gyratory

Camden Cyclists (by Kaveh Kordestani), July 2025

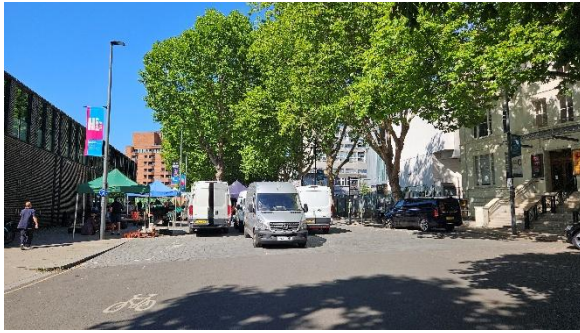
*Fig 1.1: shared space from Eton Ave*

- **1** This is a shared-use space (fig 1.1).
- On Wednesdays there is a farmers' market. Whilst this often leads to obstructed routes for cycles, cycling is still possible (fig 1.2).
- If following the LCN Link, cycles enter this area by coming northwards on Winchester Road and turning left onto Eton Avenue.
- Owing to the moderate pedestrian volumes, this **works effectively**.

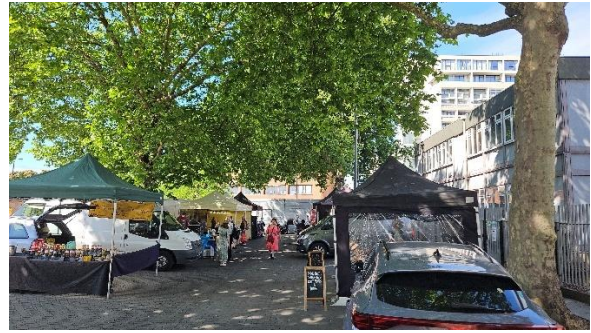
*Fig 1.2: path during market hours*

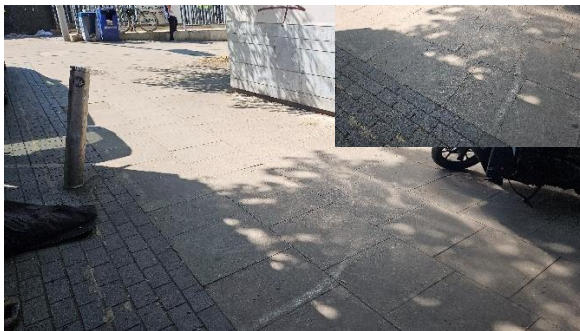
*Fig 2.1: beginning of cycleway (v. faded)*

- At **2** there is a separate cycleway.
- Fig 2.1 shows its very poor condition. Many of the paving stones have been rearranged and the markings have not been reapplied.
- Fig 2.4 shows where the paving changes. The green has faded greatly and is less evident to pedestrians.

- The cycleway at **2** has been poorly maintained. Its paint and paving is faded, is in a suboptimal location both due to its proximity to the market storage area and due to the collision risk from southbound cyclists on College Crescent.

- **Recommendation 1:** the cycleway at **2** should be realigned to be closer to the tube entrance to provide sufficient separation. It should also be repaved and remarked.

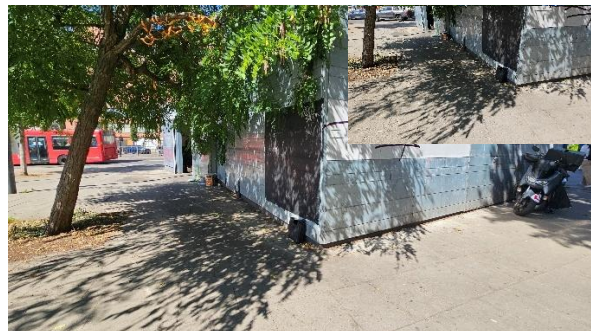
*Fig 2.2: cycleway during market hours*

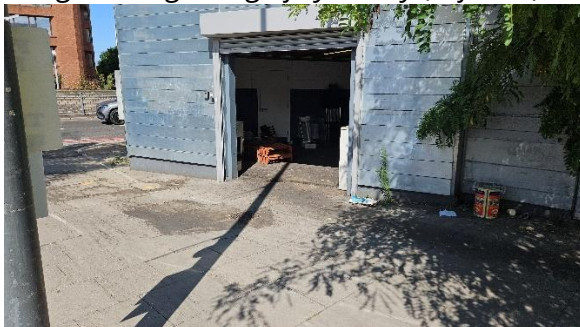
*Fig 2.3: traders' storage behind cycleway*

- On market days (Wednesday), the cycleway is directly adjacent to the market storage area (fig 2.3). This means that it is usually blocked and/or there are traders entering/exiting over the cycleway.
- Camden's 2011 plans to realign this towards the station entrance, rectifying the above issue, was not followed through.
- Owing to the above, there is no longer a clear delineation between pedestrian and cycle infrastructure and as a result there is unintentional infringement by both users.

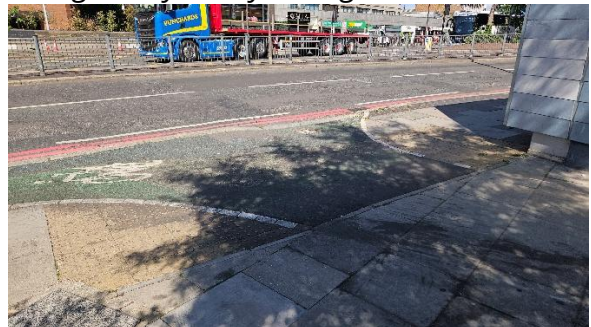
*Fig 2.4: paving change of cycleway*

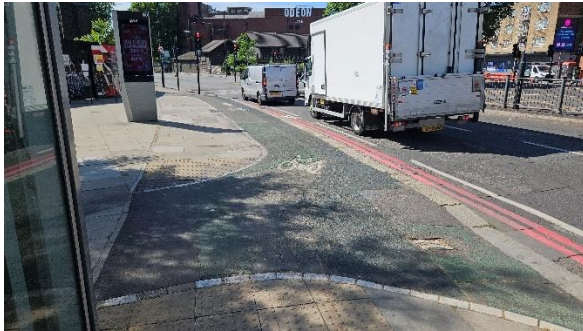
*Fig 2.5: length of cycleway to toucan*

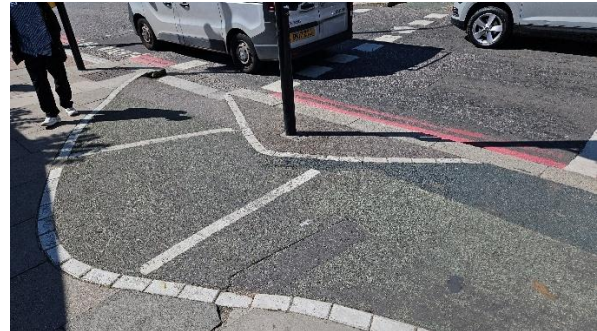
*Fig 2.6: "jug handle" before toucan*

- Further down from **2** is a toucan crossing to the central island.
- There is a jug handle for cyclists (fig 2.6). It is poorly designed as does not afford cyclists an adequate view of southbound traffic. There are also two stop lines, neither of which are optimally placed.
- The toucan crossing has low-level cycle signals for cyclists throughout with early releases (fig 2.7). The traffic signals are excellent.

- The jug handle after **2** is poorly designed and does not adequately serve its purpose. The second refuge island at **3** is too short, is awkward to use and has incorrect markings.

- **Recommendation 2:** the jug handle at **2** should either be redesigned to be perpendicular to College Crescent or straightened earlier. The refuge island at **3** should be reconfigured to be longer, face away from traffic and have appropriate road markings.

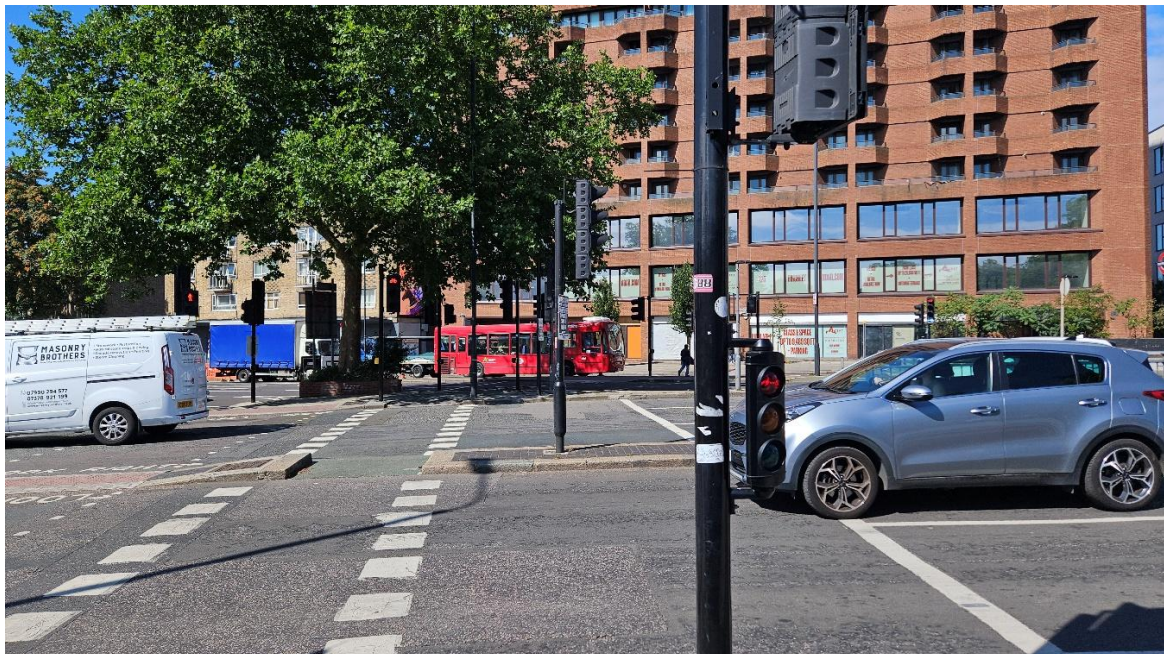
*Fig 2.7: toucan crossing*

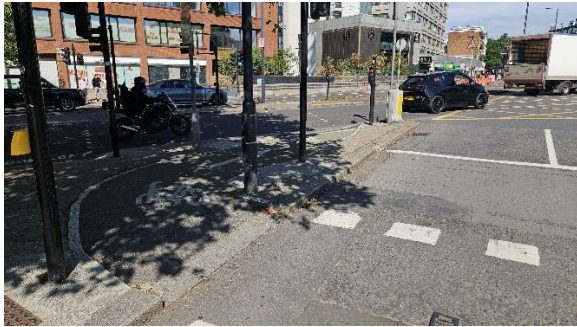
*Fig 3.1: refuge island 1*

- The refuge island at **3** (fig 3.1) has an awkward turn for cyclists but is otherwise all right.
- The second refuge island (fig 3.3) has an odd kink and is only long enough for one cyclist, causing issues when multiple use the crossing.
- The dotted lines are problematic as they encourage cyclists to continue straight and thus directly into a fence (fig 3.4). This is also promoted by the curve of the second refuge island to be perpendicular with the road.
- There should be right turn arrows for cyclists at this point and the cycleway should curve rightwards.

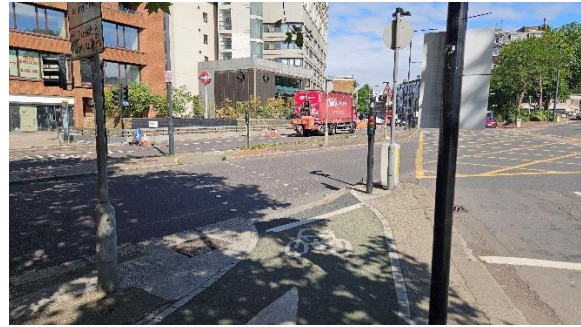
*Fig 3.2: crossing to refuge 2 with LLCS*

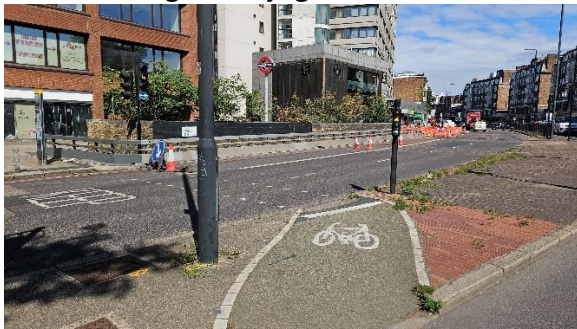
*Fig 3.3: refuge island 2*

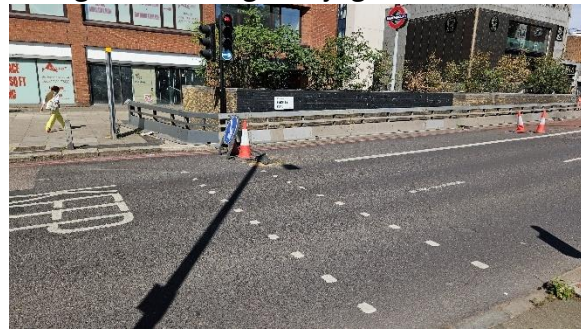
*Fig 3.4: carriageway join from refuge 2*

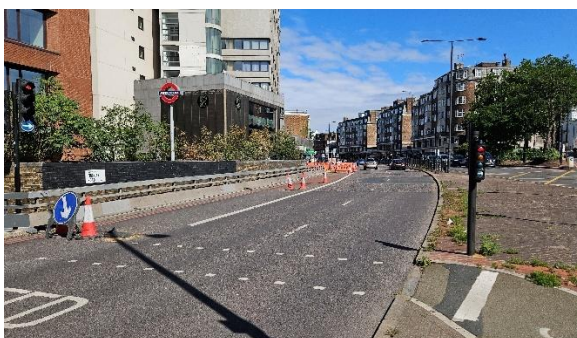
*Fig 4.1: bus lane cyclists are advised to use*

- The bus lane to be used at cyclists after this point at **4** through to **9** is incredibly poorly paved (fig. 4.2) and often filled with LGVs (fig 4.3; loading bays are in operation from 07:00–16:00) meaning cyclists have to weave back into the main carriageway, causing unacceptable risk.
- The guardrail for the length of the ventilation shaft also means there is no refuge opportunity for cyclists (fig 4.1).

- **Recommendation 3:** the bus lane at **4** towards **9** should be repaved. Loading bays should have reduced times, be moved northwards or be eliminated entirely. The guardrail should be removed if possible.

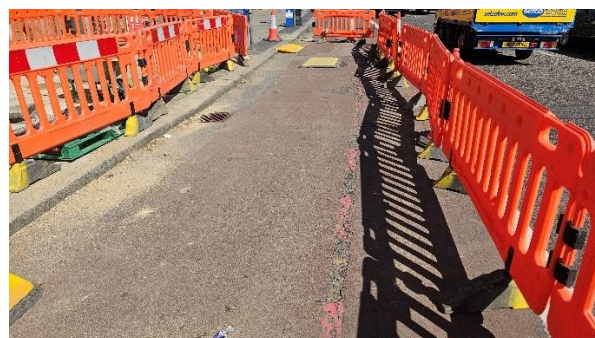
*Fig 4.2: poor and rough paving in bus lane*

- The bus lane at **4** and towards **9** is bumpy and difficult for cyclists to use. Overly generous loading restrictions mean that it is frequently blocked. An obtrusive guardrail makes it difficult for cyclists to seek refuge.

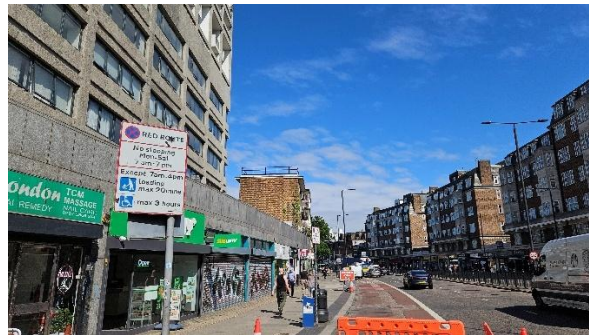
*Fig 4.3: loading bay directly after guardrails with broad time of operation*

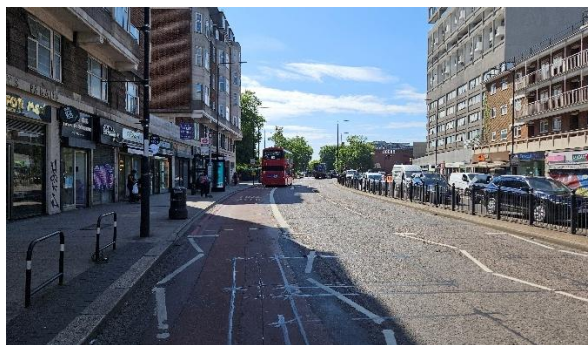
*Fig 5.1: bus lane leading to **6***

- Beginning at **9**, cyclists must stay in the bus lane to proceed on this route. It is frequently blocked as there is a bus stop at **5** that serves four routes (fig 5.1).
- There is no dedicated left turn lane to enter the area at **6** (fig 5.2). Neither is there any segregation, meaning that cyclists share this small area with double-decker buses.

- Buses frequently block southbound cyclists at **9**. Cycles have to share a small off-carriageway area at **6** with buses and have poor sightlines of oncoming traffic from the left. The refuge area in the central reservation at **7** is inadequate.

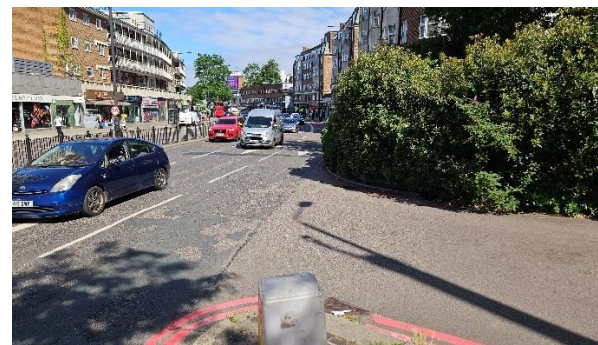
*Fig 5.2: turning lanes into **6***

- **Recommendation 4:** ideally the entire area at **6** and **7** should be redesigned. At the very least, there should be an attempt to clear up street furniture and widen the refuge area.

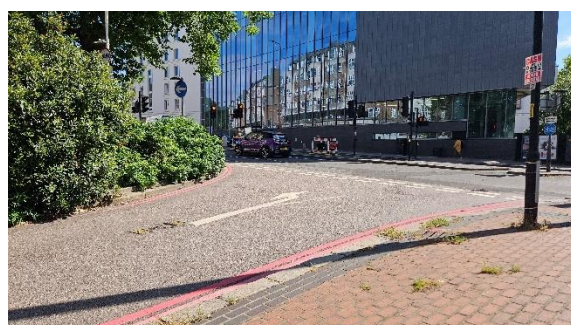
*Fig 6.1: area at **6** with left-hook risk*

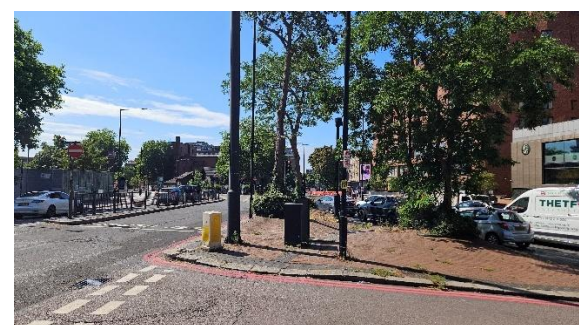
*Fig 6.2: obstructive street furniture*

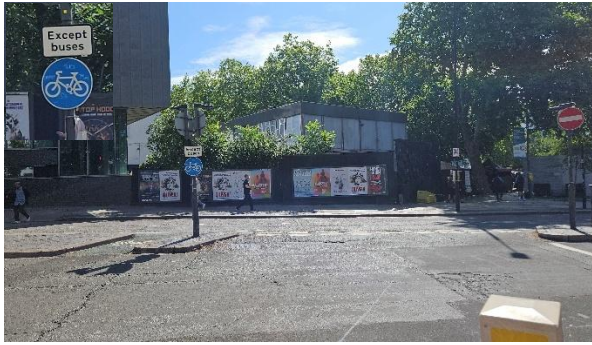
Fig 7.1: cycle/bus only crossing area

- The carriageway after has a central reservation at 7. There are two gaps, one for cyclists and one for buses (fig 7.1). No other vehicles may enter.
- Buses turn both left and right from 6. The cycle gap is on the left. This means that cyclists who cross into the reservation are at risk of being left-hooked by a turning bus (fig 6.1).
- There are no traffic lights. Street furniture and trees make it difficult to see any oncoming traffic from the right (fig 6.2). Having just come off one carriageway, it is easy and tempting for cyclists to not slow down and continue on, with northbound traffic in a blind spot.
- The gap for cycles in the pedestrian refuge is insufficient, especially given that cycles often have to wait for southbound traffic on College Crescent before exiting (fig 7.2).

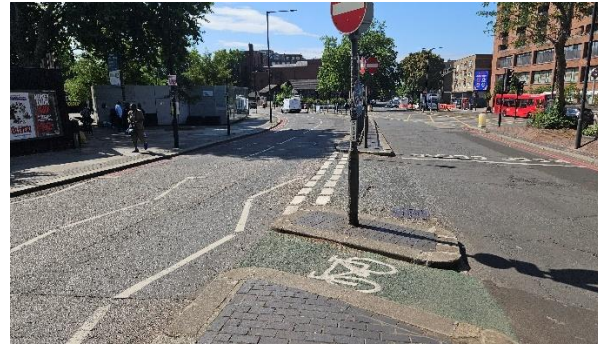
Fig 7.2: cycle refuge area at 7

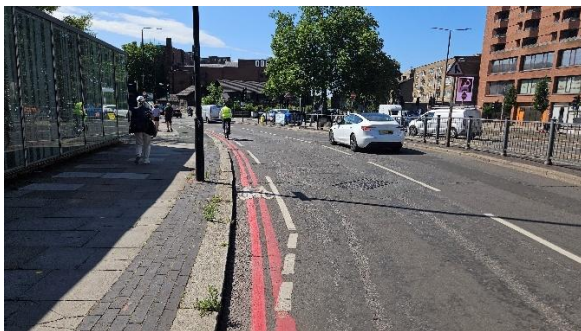
Fig 2.8: v. narrow feeder lane to exit at 2

- After continuing southbound along College Crescent, cyclists are encouraged to join back into the LCN network by exiting left onto the cycleway at 2 (fig 2.9).
- This is very poorly planned. Firstly, the actual exit of the carriageway is a 90° turn making it impractical to join. Secondly, it pushes rapidly moving cyclists into oncoming cyclists who are continuing to the toucan crossing.
- Considering that the cycleway here is only designed for westbound users, this creates a possibility of collision both with pedestrians and other cyclists. This is especially problematic given that these users are blocked by the traders' storage building.
- The feeder lane for this exit is also dangerously thin: about half a metre (fig 2.8).

- *Unfortunately, cycles and buses cannot be easily separated in the current state of this area as buses turn both left and right.*
- The southbound cycle lane on College Crescent after **7** and leading up to **2** is dangerously (and illegally) narrow. The point at which cyclists rejoin the Eton Avenue cycleway is bumpy and has a high collision risk both between cyclists/pedestrians and other cyclists.

- **Recommendation 5:** the cycle lane should be widened to at least 1.5m, ideally 2m or above. Cyclists should ideally join onto the pavement area earlier or at least at a point that has a lower collision risk (perhaps from the north of the traders' area).

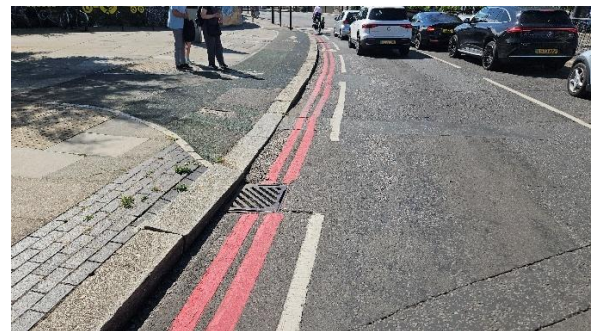
Fig 2.9: joining area at 2

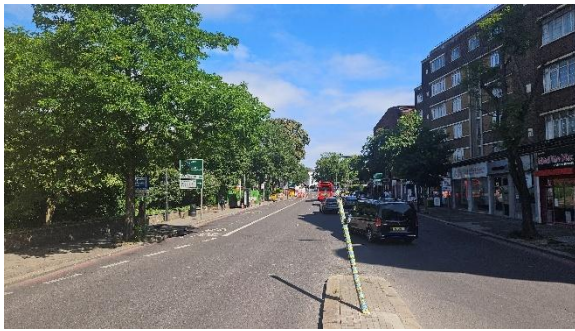
Fig 12.1: looking northbound to Finchley Rd

- The turning movement from Hilgrove Road (left side of fig 12.3; left onto Finchley Road) is okay. When turning left there is a bus lane that cyclists can enter (9; fig 12.1). There is one bus route (31) that provides some left-hook risk. An ASL should be installed here.

- There is no ASL or cycling facilities on the northbound movement of Finchley Road (fig 12.1, fig 12.3). Considering the high bus and HGV volume here this is poor. Knowledgeable cyclists use the left turning lane which has an exception for buses and cyclists continuing into the bus lane (fig 12.1), but this is poorly indicated.

- **Recommendation 6:** where a feeder lane can be adequately installed (i.e. not in some awkward configuration between lanes) ASLs should be installed. Other recommendations would require the entire junction to be reconfigured (such as some segregated cycling provision on southbound Finchley Road).
- The modal bypass at St John's Wood Park is useful for cyclists. It is poorly promoted and has not been repaved in some time.
  - **Recommendation 7:** the St John's Wood Park modal bypass should be repaved. It may benefit from indicative road markings for cyclists. The pedestrian refuge island could be shrunk to provide a dedicated cycle facility towards this bypass.
- The Avenue/Finchley Road/Adelaide Road junction suffers from mostly the same issues as that with Hilgrove Road.
  - **Recommendation 8:** refer to recommendation 6.

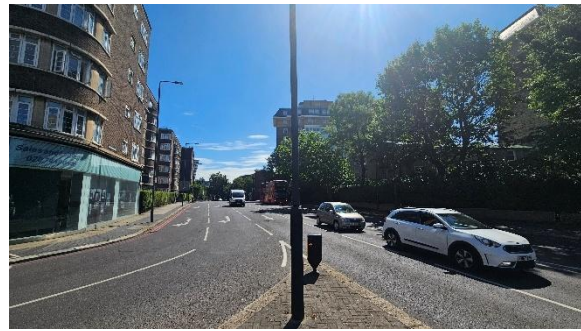
Fig 12.2: looking east from 10

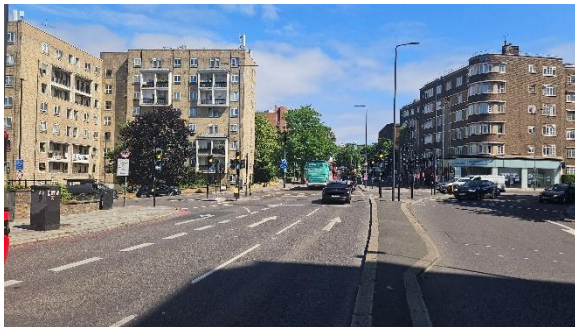
Fig 12.3: looking north before junction

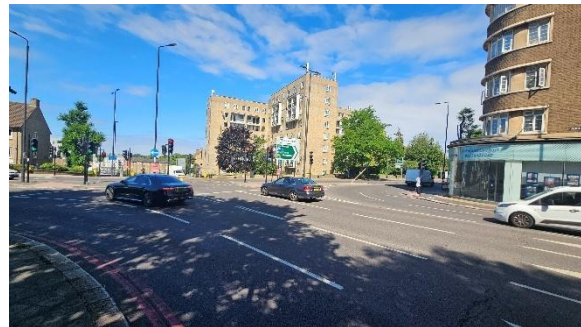
Fig 12.4: looking west towards 10

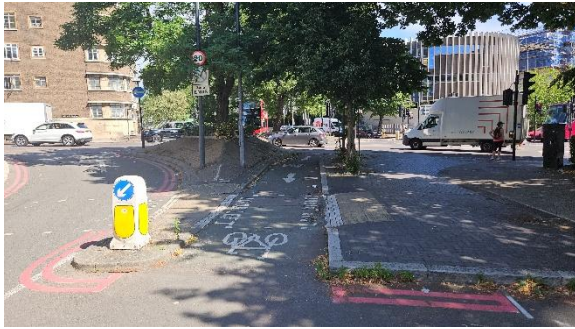
*Fig 13.1: St John's Wood Pk modal bypass*

- St John's Wood Park joins Adelaide Road just west of the main junction at **13**. The road is two-way with no entry from Adelaide Road.
- There is a separate cycle facility that enables cyclists to enter this road directly from Adelaide Road as part of the LCN link (fig 13.1). It is very poorly paved (fig 13.2) and not particularly evident to most cyclists (fig 13.3), despite offering a very useful entrance to an important side road.

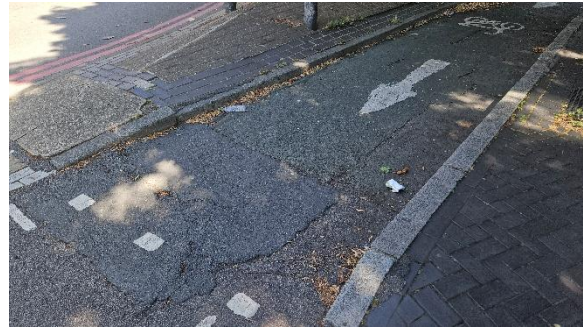
*Fig 13.2: very poor surfacing on bypass*

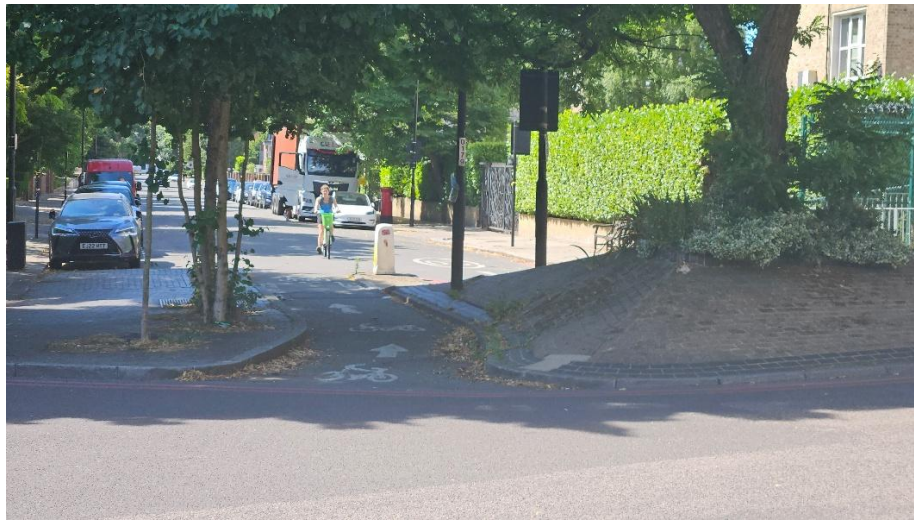
*Fig 13.3: south-facing view of bypass*

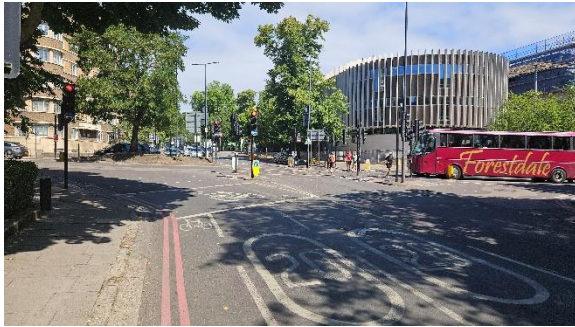
Fig 16.1: north from Avenue Road (14)

- The north-west movement from Avenue Road is so far the only in this junction to have an ASL (and even a feeder lane!). This does not offset the fact that cyclists will immediately turn into a dangerous six-lane road though the risk is reduced as this has its own signal phase.

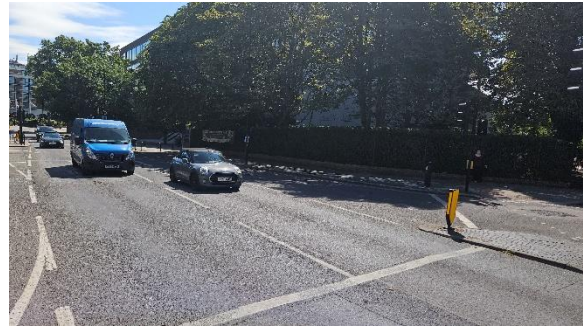
Fig 16.2: east from Adelaide Road (15)

- The westwards movement from Adelaide Road is okay. The road is narrowed until this point and so it feels slightly safer, though this too faces the same six-lane peril (without an ASL).

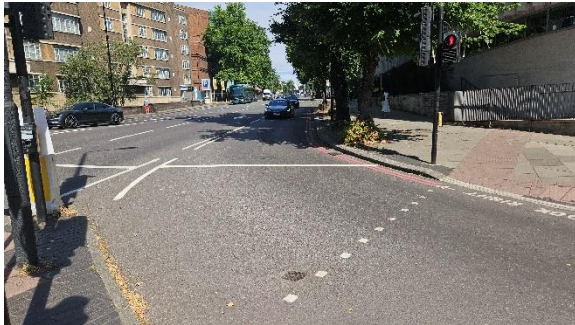
Fig 16.3: north from Adelaide Road (e, 16)

- The southwards movement into Avenue Road from Adelaide Road is one lane, slow and generally all right.
- Any movements south from Avenue Road (16, north) are difficult for cyclists. Getting here is arguably the worst part of the junction given the five lanes and criss-crossing buses and HGVs. Unless entering the gyratory from a position that is opportune to their final movement, it is very difficult for cyclists to change lanes here without great risk, especially between the left- and right-turning lanes.

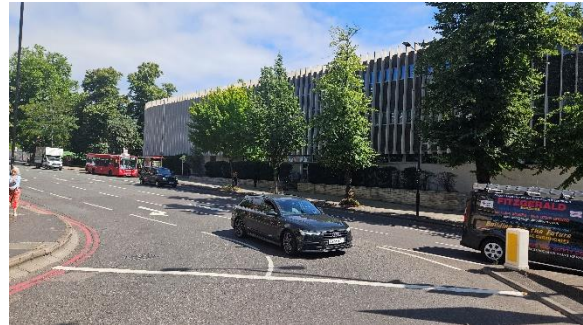
Fig 16.4: north from Adelaide Rd (w)
