Audit of Chalk Farm Road cycle tracks

Camden Cycling Campaign, report on audit carried out on 1st July 2021

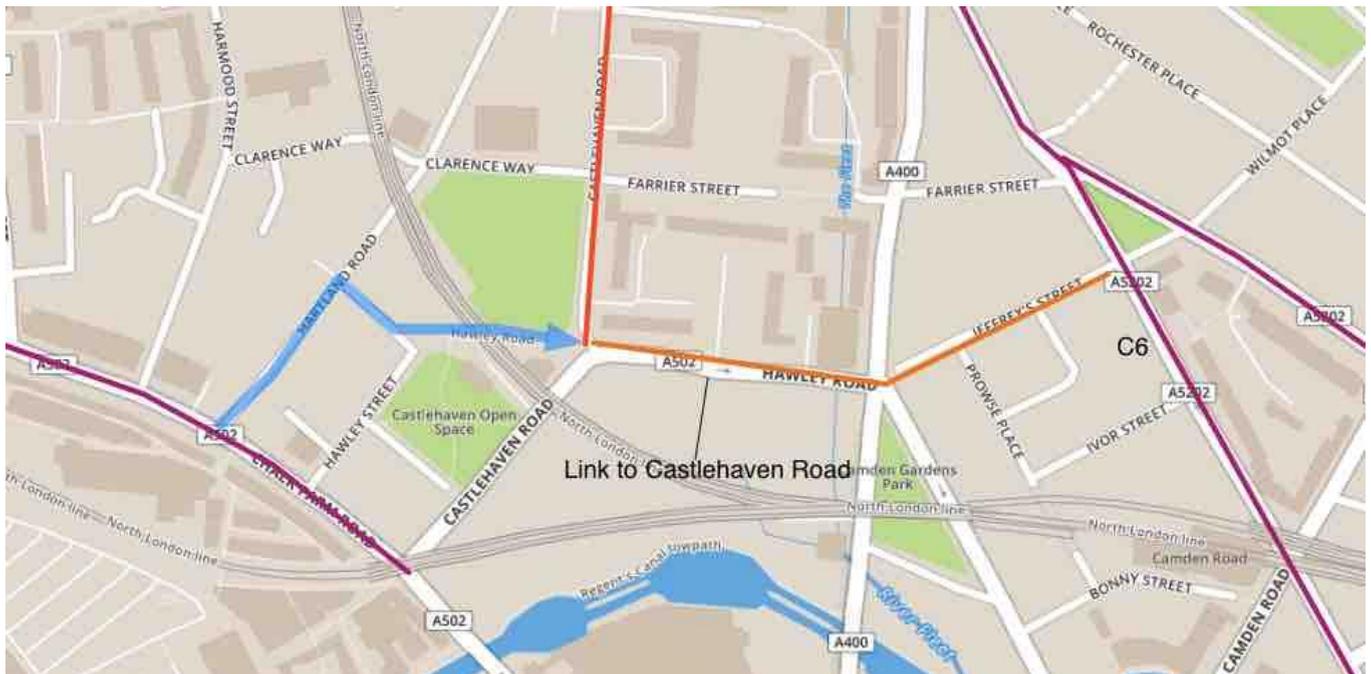
Southbound cyclists need very clear signage to C6 through Hartland Road via the cycle tracks across Castlehaven Open Space on to the junction of Castlehaven Road and Hawley Road (blue line on our map), continuing via Jeffrey's Street. This [little direction sign](#) on Hawley Road mentions Camden Town but not C6.

But how is anyone to return to Chalk Farm Road from C6? Two-way cycling on Hawley Road is essential and westbound crossing through Jeffrey's Street across Kentish Town Road and a scheme to provide this should be prioritised.

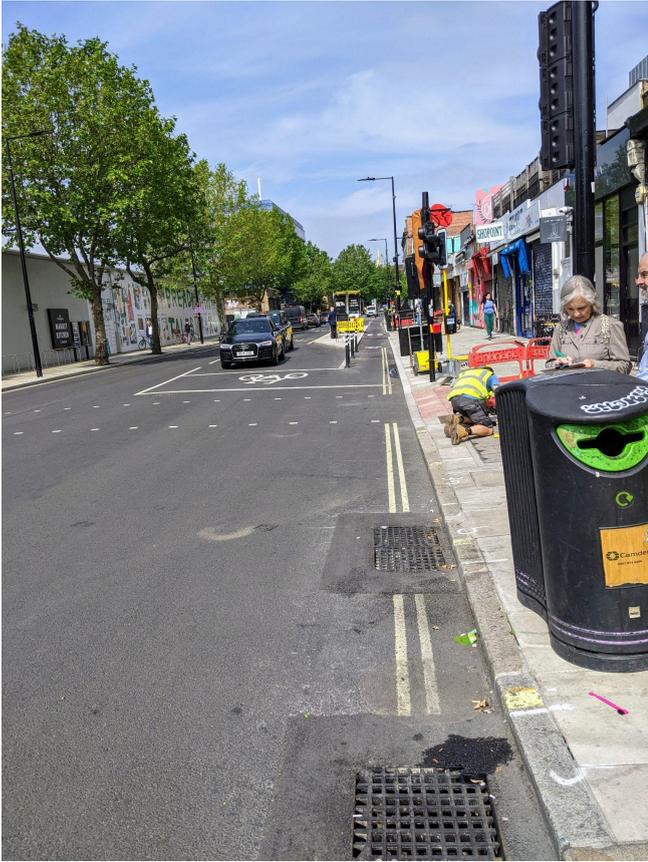
Figure 1a. View north from Ferdinand Street. Needs lines and logos. Solid line as far as Ferdinand Street and dashes across the junction

- Lines and cycle logos on Chalk Farm Road should be marked through the junction across both Ferdinand Street [Figure 1a](#) and Juniper Crescent [Figure 1b](#). The lines should be solid between the pedestrian crossings and the side roads; they should be dashed across the side roads.

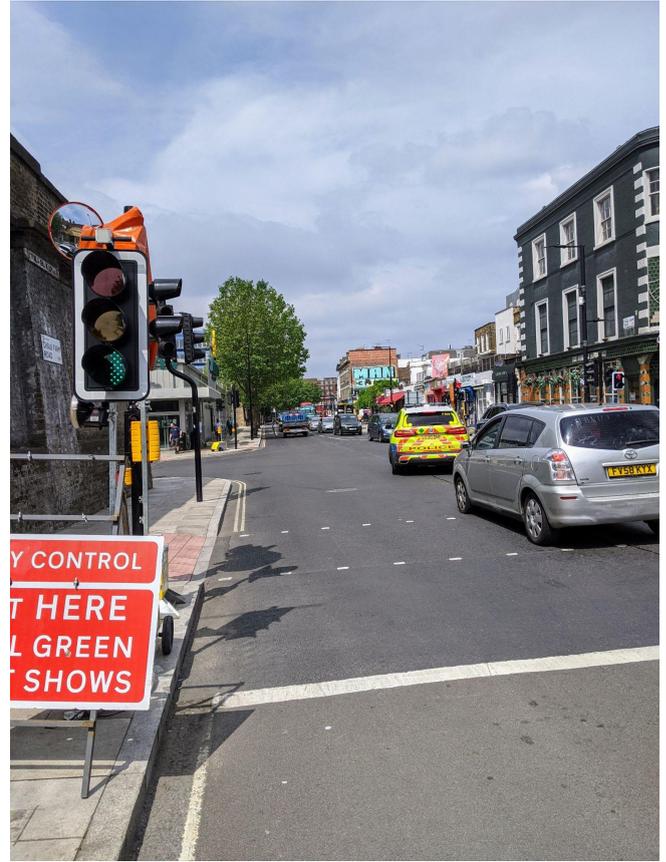
Figure 1b View north towards Juniper Street. Needs lines and logos. Solid line as far as Juniper Street and dashes across the junction

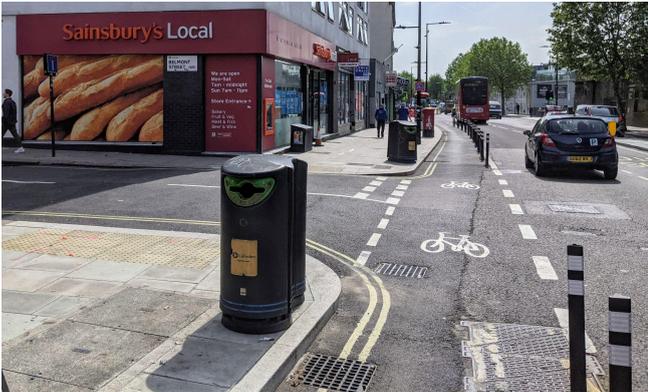
This junction is good in that the mandatory lanes and bollards stop close to the side road and the crossing is correctly marked with lines and logos. See [Figure 2](#).

Figure 2. Belmont Street. The mandatory lanes and bollards stop close to the side road and the crossing is correctly marked with lines and logos

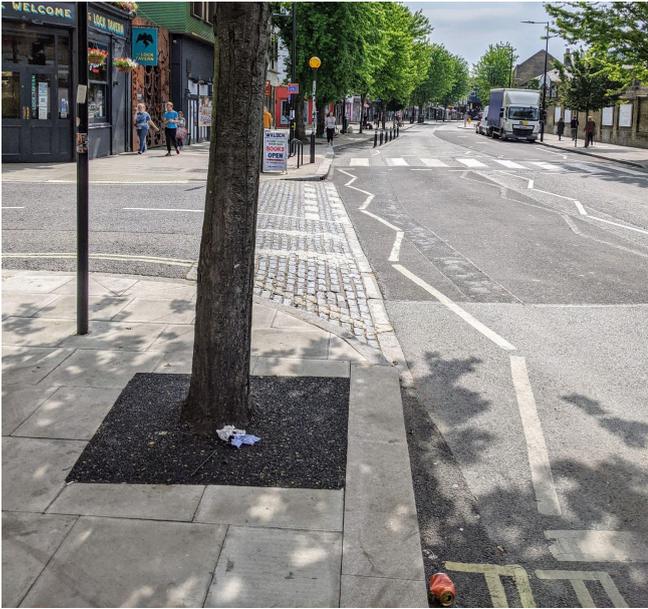
Figure 3. Harmood Street. Separate zebra tails should be painted as an extension to the cycle lane.

- Extra zebra tails should be used to show the edge of the cycle lane as it crosses the junction. See [Figure 3](#)

This [example from Royal College Street](#) shows how zebra tails should be marked when a cycle lane crosses a junction close to a zebra crossing.

We have already mentioned in point 4 that on the approach and across Harmood Street, an extra line of zebra tails should extend the cycle lane. The mandatory cycle lane and bollard protection starts very soon after the crossing as they should. See [Figure 3](#).

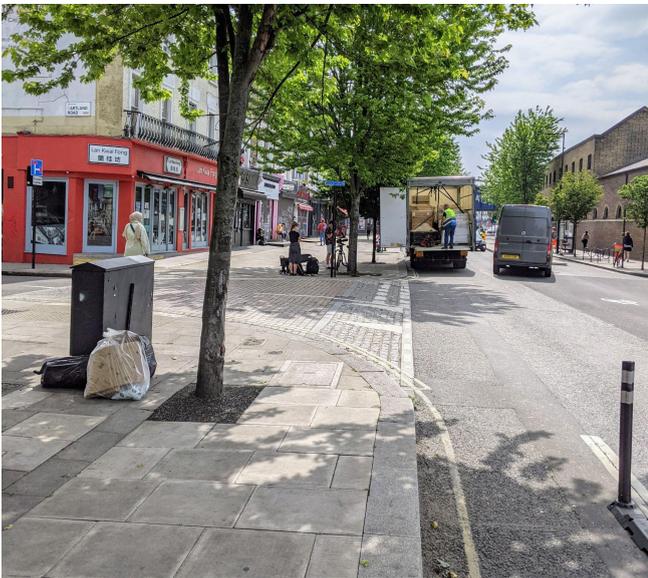
We understand from the Phase 1 drawing that the southbound infrastructure ends here and that cyclists will be encouraged to continue their journey via Hartland Road.

Figure 4. Hartland Road. Even though the southbound infrastructure ends here, we would like to see a lane with logos marked across this junction for people who want to continue southbound.

- We would like to see a lane with logos marked across this junction for people who want to continue southbound. See [Figure 4](#).

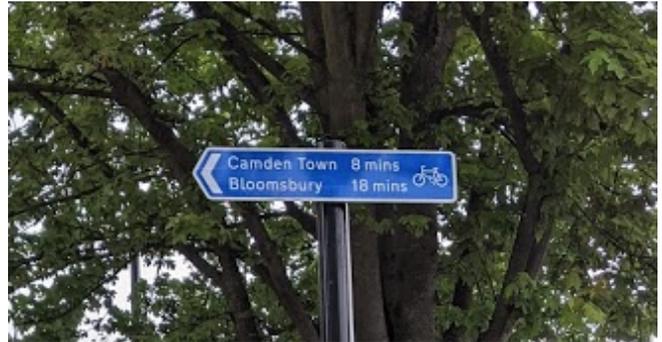
We note that a direction sign here points to Camden Town and Bloomsbury. As we can't see this sign on [StreetView](#) (Jan 2021) we assume it must be a new one.

The sign at this junction points to Camden Town and Bloomsbury.

- We believe that more emphatic signage is needed here and that destinations should include C6 and Kings Cross, with further similar signage along Hartland Road and Prince of Wales Road.

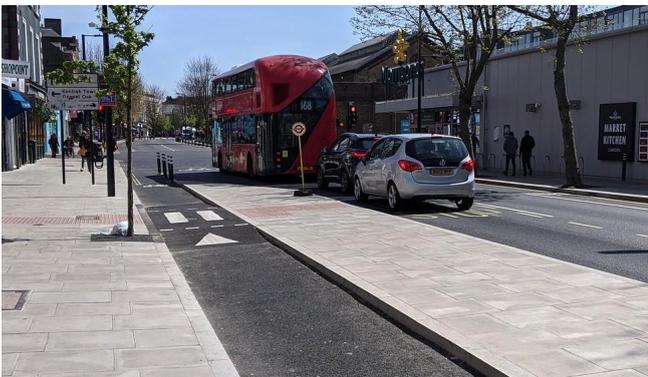
Figure 6. Bus stop bypass opposite Morrisons temporary store. (Photo taken before road works started)

- The bus stop bypass opposite Morrisons has the flag on the island. See [Figure 6](#). Is it the intention to relocate the shelter there as well?
- We note that the three other bus stop bypasses have the shelter on the footway, whereas the normal practice is to site the shelter on the island. Is this intentional? (These are located outside the Stables Market House, outside the Round House and opposite Haverstock School ([Figures 7a](#), [7b](#) and [7c](#)). If there is room, we think it may be better to have the shelter on the island to leave more space on the footway and to stop a sudden rush across the cycle track when the bus arrives.

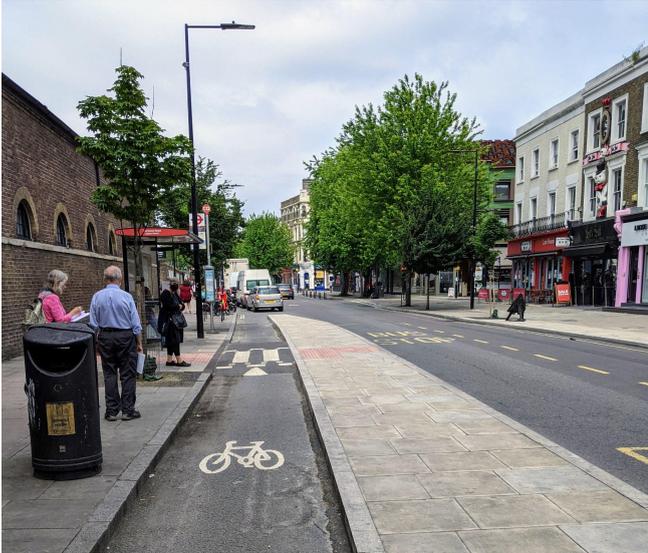
Figure 7a Bus stop bypass outside Stables Market. Shelter on footway.

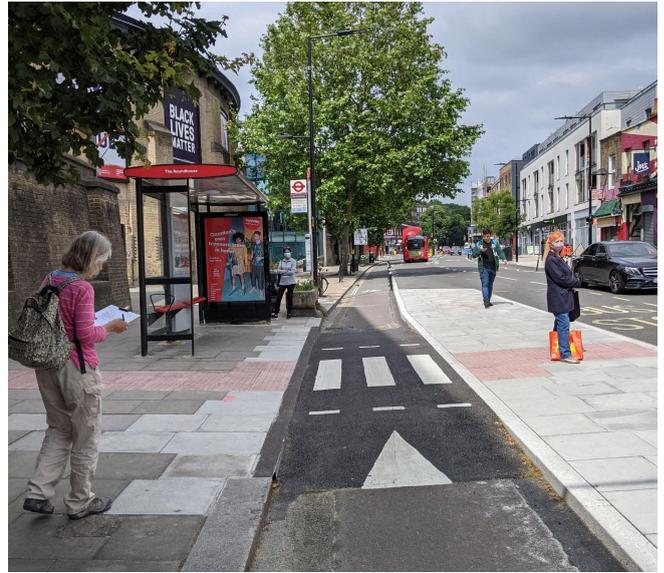
Figure 7b. Bus stop bypass outside the Round House. Shelter on footway.

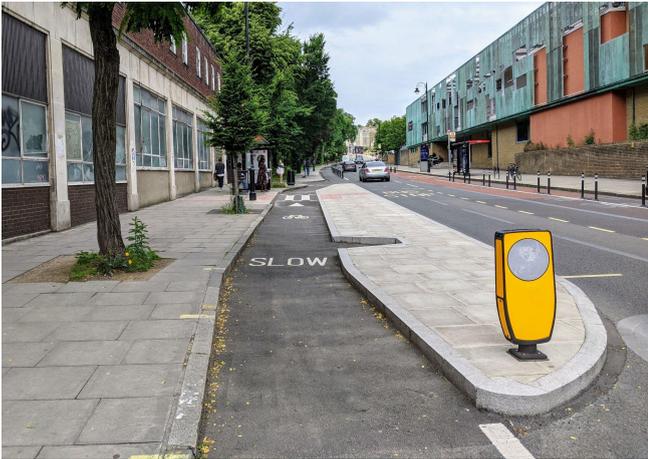
Drainage issues. The bypass opposite Haverstock School suffers from pooling and subsequent collection of debris on the uphill side of the raised section. There is a gully but it may be blocked.

Figure 7c. Bus stop bypass opposite Haverstock School.

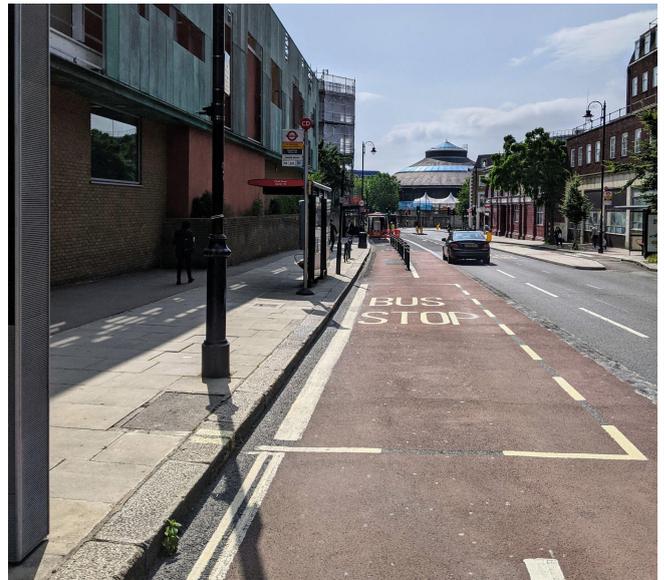
This is a 'ride round' bus stop. See [Figure 7d](#). We would have preferred a SUBB but acknowledge that there's not room to fit in a 2m wide SUBB. According to the Phase 1 drawing, the carriageway width here is only 6.5m, after taking 2 x 1.7m for cycle lanes on both sides of the road,

Figure 7d Bus stop outside Haverstock School

- As there is room for cyclists to ride round, logos should be painted outside the corners of the bus cage.

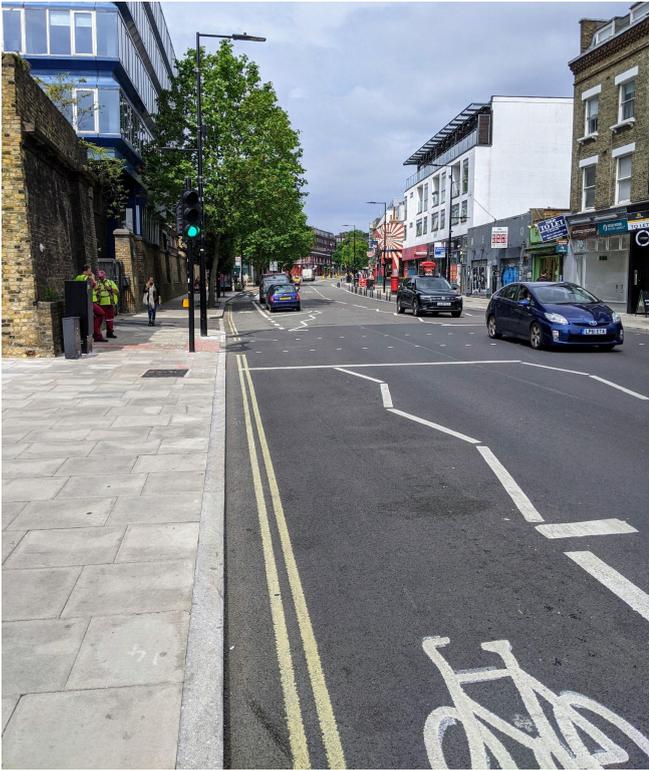
This crossing is on the northern side of the now closed junction of the road up to Juniper Crescent. We like the short tails. See [Figure 8](#).

Figure 8, Signalised pedestrian crossing - short tails (looking north)

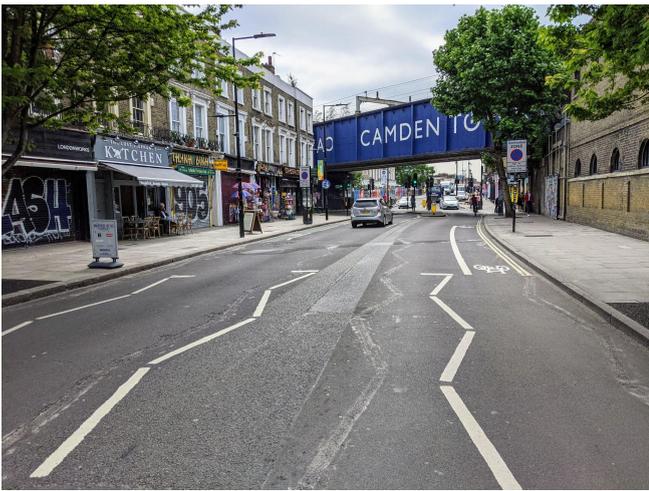
This crossing is between the short section of cycle lane north of the Castlehaven Road junction and the bus stop bypass outside the Stables Market. See [Figure 9](#).

Figure 9. Short section of cycle lane north of the Castlehaven junction,

- It may be worthwhile providing a Tiger crossing here to enable cyclists coming from further east to join the northbound cycle track.

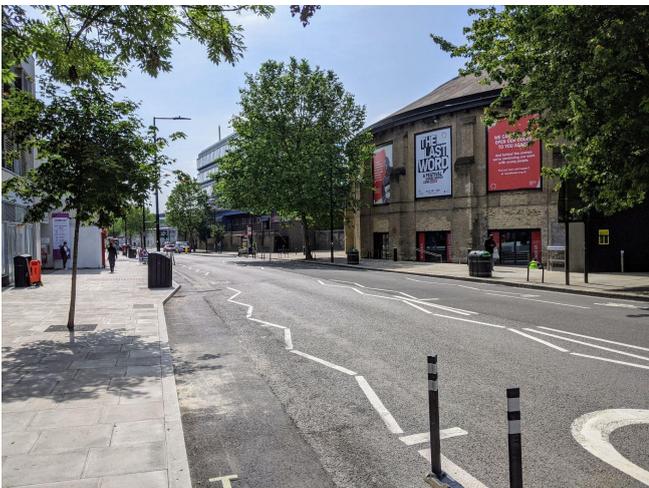
Looking south with the Round House opposite. See [Figure 10](#). There is a big gap in the cycle lanes here on both sides of the road. We can see from the Phase 1 drawing that a signalised pedestrian crossing is specified.

- Unfortunately there is a large break in the protected infrastructure on both sides of the road outside the Round House due to the mystery long tails mentioned above. See [Figure 10](#) and the northbound video at about 2:37 - 2:41. The zebra tails do act as an indicator for a cycle lane but less confident people would be more comfortable with continuous bollard protection.

Figure 10. Looking south with the Round House opposite. There is a big gap in the cycle lanes here on both sides of the road.

- Until a crossing is installed the protected cycle lanes should be marked through this section. And if a crossing is implemented, we would like it to have the shortest possible tails.

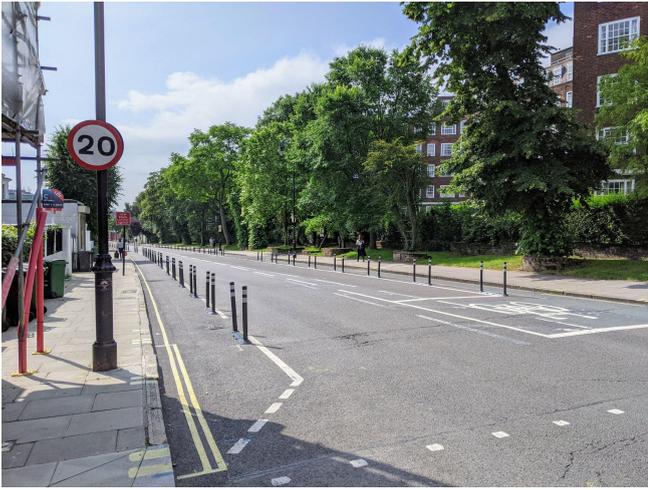
The mandatory cycle lane and bollards run almost uninterrupted through this stretch. See [Figure 11](#). This photo is one of the places where the yellow lines are inconsistent – the single yellow line with double yellow near the junction was inherited from an earlier scheme (the Prince of Wales westbound tracks).

Figure 11. Haverstock Hill cycle tracks. Yellow line markings?

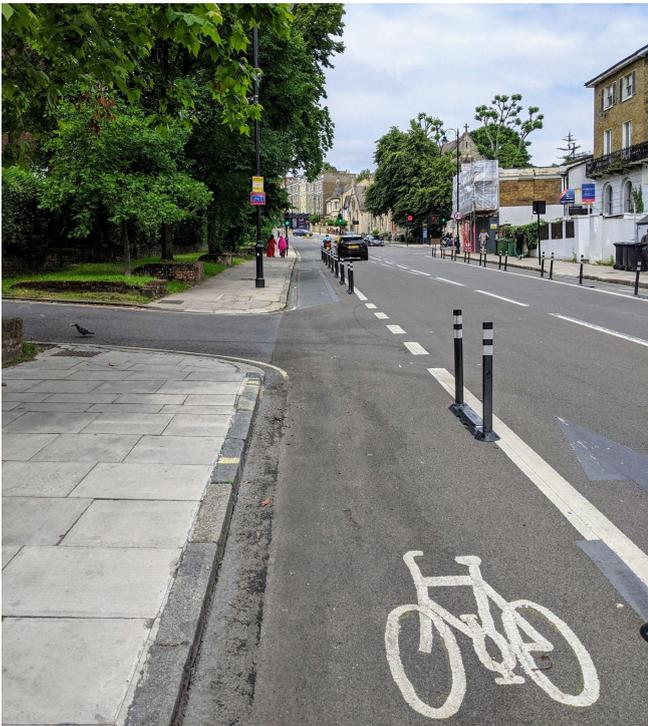
Figure 12. The second entry to Eton Hall on the northbound side. Needs logos across the junction. Note also no yellow lines.

- An advisory lane is painted where the cycle track crosses entrances (e.g. by the medical centre and the school southbound and by the two entrances to Eton Hall northbound), logos should be marked on the road across all of these entrances. See [Figure 12](#). Note also the lack of yellow lines.
- The southbound video from 0:33 to 1:20 and the northbound video from 3:35 - 4:20 confirm a continuous riding experience through this section. Apart from **a nasty pothole** soon after the bus stop at 1:10 southbound.
- **Railings on the southbound approach to Crogsland Road.** See [Figure 13](#). This long stretch of railings needs to be removed.

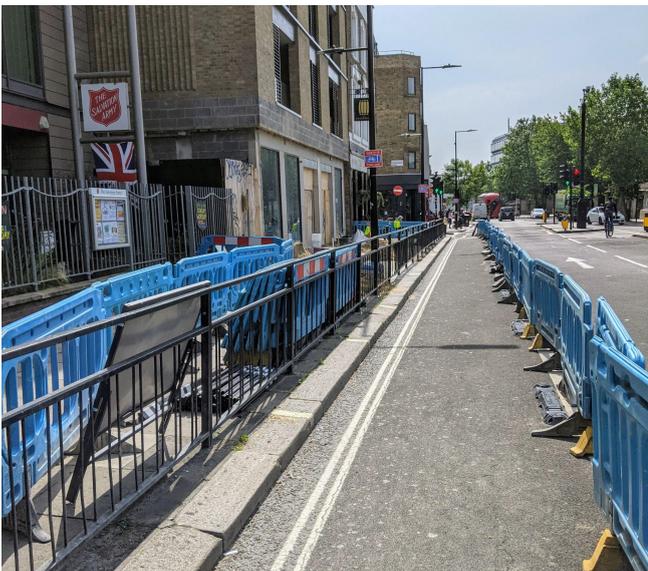
Figure 13. A long line of railings between the pedestrian crossing on the north arm and the junction with Crogsland Road. There normally are bollards here but someone has dismantled them. See [this photo](#).

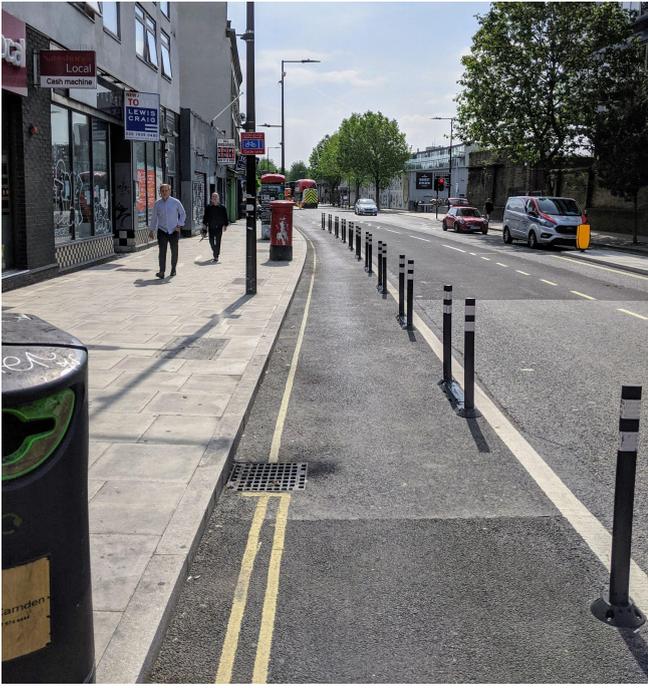
Two parking bays have been neatly fitted in outside the track on approach to the bus stop bypass. See [Figure 14](#) and also the northbound video at about 2:22.

Figure 14. Cycle lane and bollards between Belmont Street and the signalised crossing. On the other side of the road is a pair of outside track parking bays and the start of the bus stop bypass outside the Round House. Note the combination of double and single yellow lines.

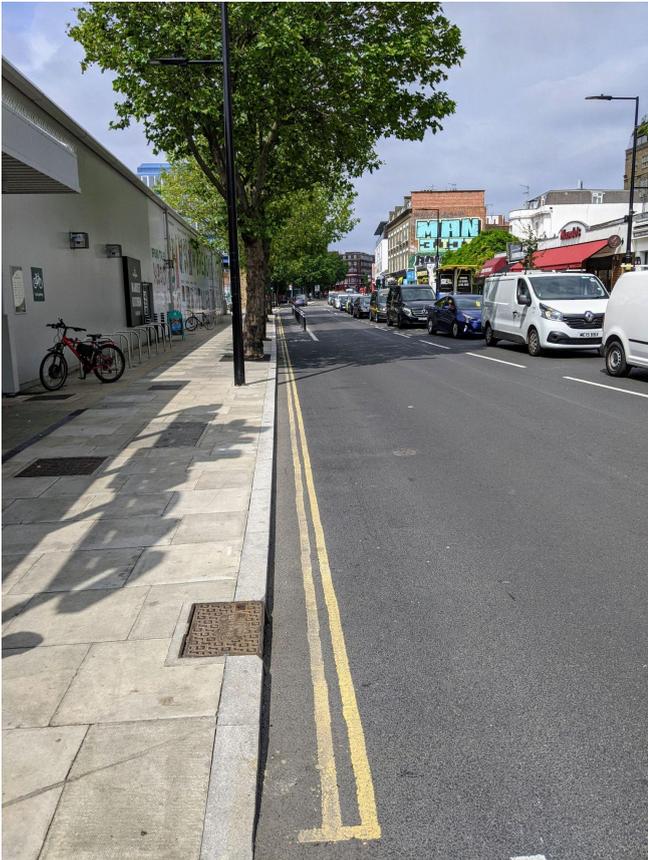
- On the northbound side there is a long gap in the protected infrastructure outside Morrisons temporary store. See [Figure 15](#). We know that space is tight but this ought to be remedied..

Figure 15. Why is there such a long gap in the protected infrastructure outside Morrisons temporary store?

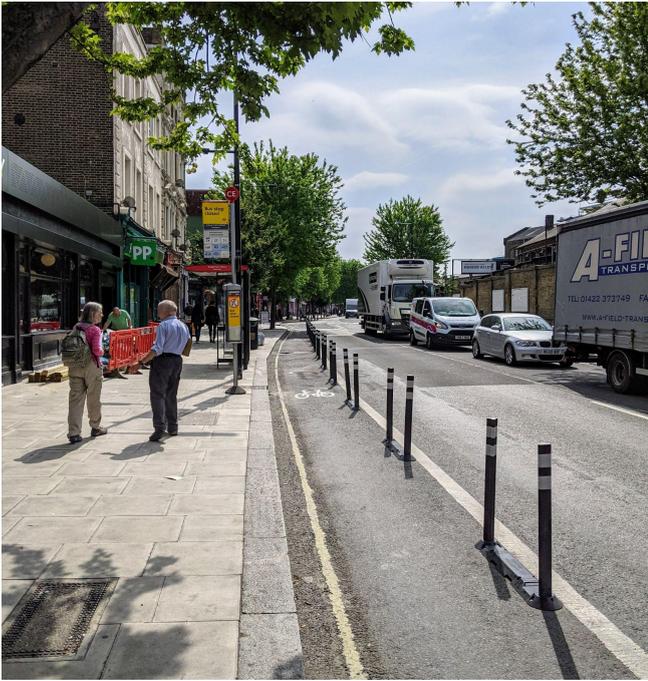
Many parking bays have been moved to side streets and traffic islands removed to make space for cycling. On the southbound side there is a good stretch of 1.8-2m wide protected cycle lane right through. See [Figure 16](#).

Figure 16. From Ferdinand Street towards Hartland Road

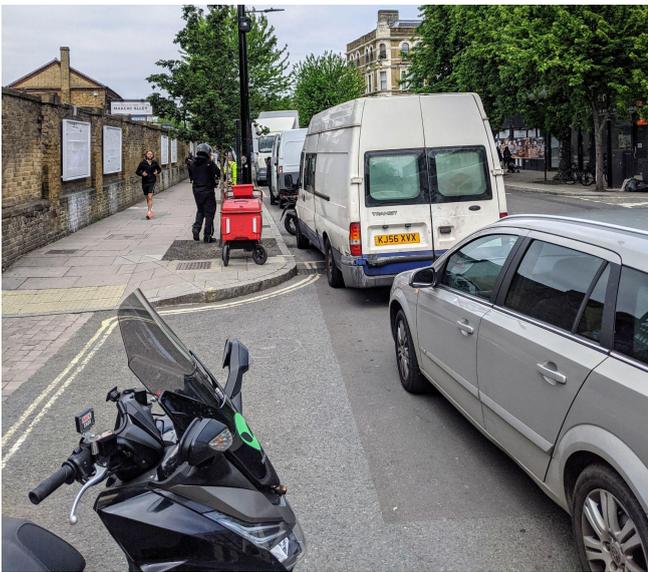
The loading bay and the taxi stands are a serious blight on the northbound route and definitely the worst feature of this scheme. No loading is allowed noon-2pm and 4pm - 10 pm. Our photo was taken at about 11am. See [Figure 17](#). Also look at the northbound video from 0:27- 1:28 to see how unpleasant it is to ride past large vehicles stopped in this space, particularly when the motor traffic is heavy. [Figure 17b](#) is a still from this part of the video.

Figure 17a. Loading bays outside the Stables.

- The presence of this long gap (16 m loading + 2 taxi stands) attracts all and sundry to stop here. We would very much like to see it go but as a less radical suggestion, the taxi stand which doesn't appear to be used much could be moved to a side road opposite. We also suggest that the area beside the loading bays should be marked with "KEEP CLEAR" to allow cyclists to ride round the parked vehicles.

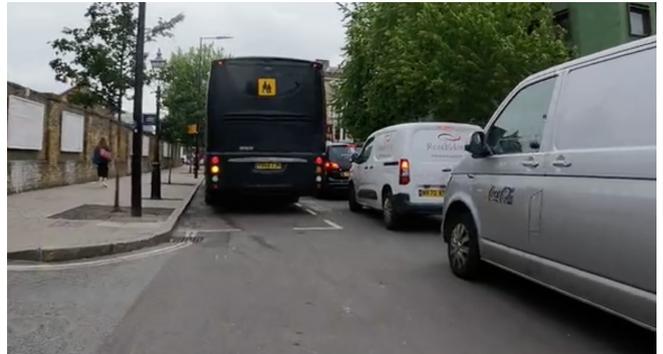
Figure 17b. The image below is a clip from the northbound video at about 9:19 am. Cycling past this school bus is very difficult.

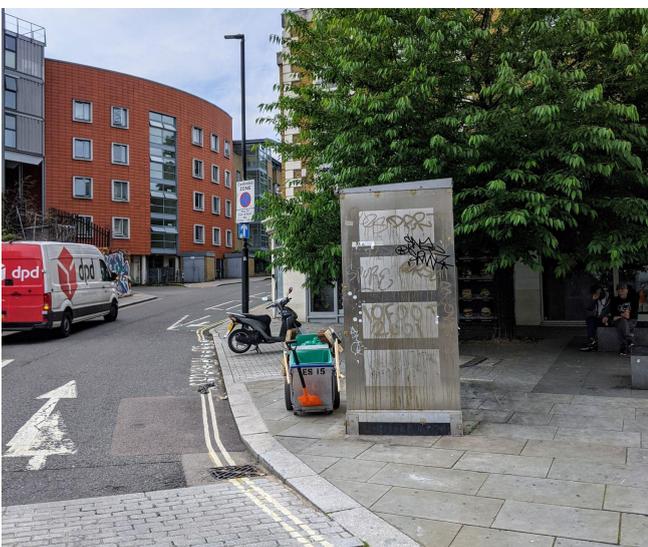
Figure 18. Redundant kiosk box that needs to be removed.

- The redundant kiosk box on the corner of Regents Park Road obscures the sight line for cyclists and should be removed, see [Figure 18](#).
- We don't like the Covid-19 cycle lane signs throughout as we think they will lead people to assume that the schemes will be removed if/when the emergency is declared to be over. See [Figure 19](#).
- Other cycle routes in Camden have double yellow lines and double blips painted throughout (except where parking is allowed outside the cycle track. See for example, [Gower Street](#) and [Royal College Street](#). We would like to see a consistent approach.

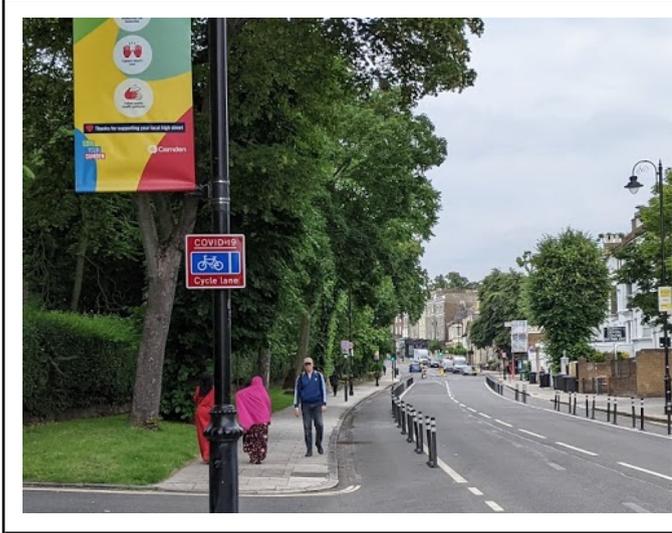
Figure 19. Covid-19 signs.
