Audit of York Way cycle tracks

Camden Cycling Campaign, report on audit carried out on 24th June 2021

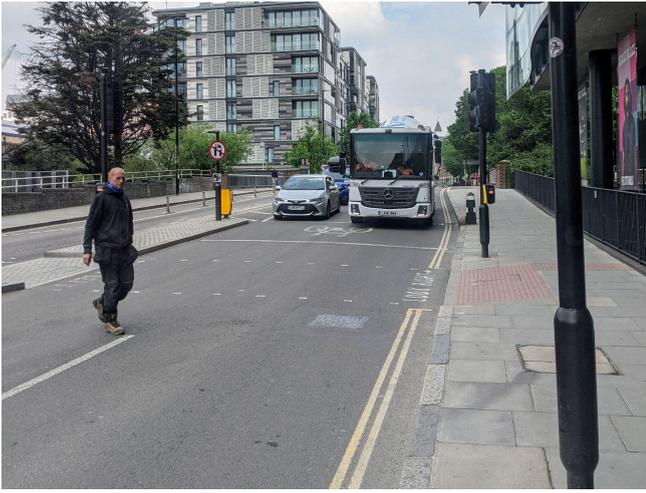
The experience riding southbound is very poor. There are two motor lanes and no cycle lane. See [Figure 1](#). The logos across the junction shown in the Phase 1 drawing are not painted on the road. Ideally, cyclists should be provided with a protected bypass lane southbound with a lane to the ASL for those wanting to turn right (as in the new Freight Lane scheme). The southbound approach is about 12.9m wide. The Phase 1 drawing shows how a pair of 2.2 m cycle lanes can be fitted in, provided that there is only one southbound motor lane. Without the central island it would be possible to fit in the Freight Lane design. The 'recent' improvements (installed in 2015) allow cyclists to turn right out of Goodsway and introduce a protected lane on the northbound approach.

Figure 1. Goodsway junction looking north up the southbound side. There is no space for southbound cycling through this junction. Not even as shown on the Stage 1 scheme drawing.

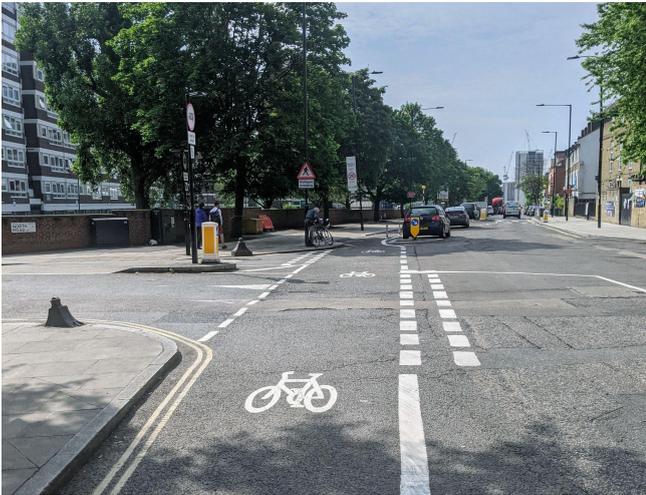
Visibility is good here and we like the extra Give Way lines. Is this a standard that could be used again? We like the island with the yellow bollard in front of the parked cars. [See Figure 2](#).

Figure 2: North Road junction showing extra Give Way line.

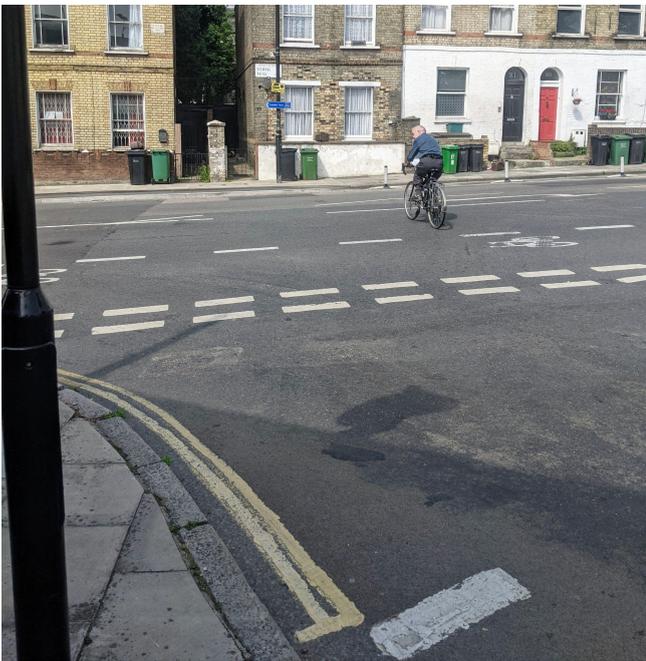
- Left hook risk for southbound cyclists (see example on the southbound video at 2 minutes); a coloured surface to emphasise the cycle lane across the junction could help.
- The right turn from Market Road into the northbound track on York Way is difficult because there is a need to look out for traffic in both directions and then find a gap between the bollards. Although we like the section of stepped track on the northbound side, we fear that someone may run into it. We therefore suggest placing a yellow bollard with an arrow and possibly a gap in the bollards to show the way in. See [Figure 3](#).
- The right turn from the northbound track on York Way into Market Road is even more difficult. People seem to leave the cycle track and take the lane, using the right-turn pocket for motors. Can this be improved?

Figure 3. Right turn out of Market Road showing the stepped track and the need to find a gap between the bollards.

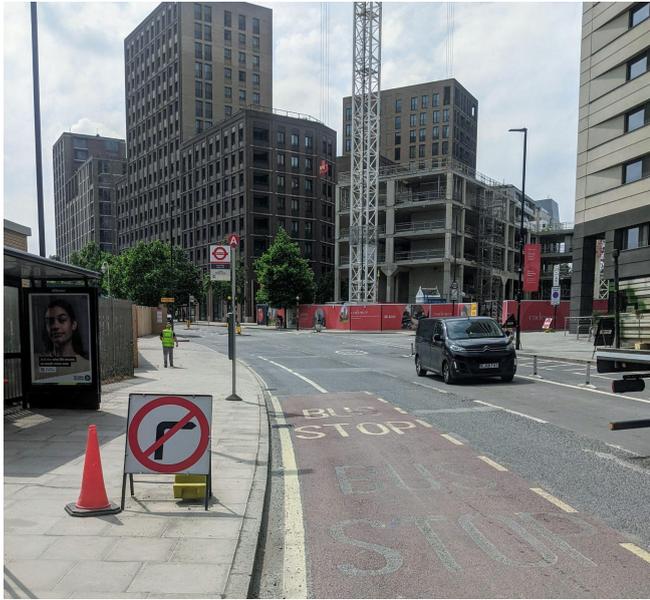
This junction (see [Figure 4](#) and also on [StreetView](#)) is in rather a poor state, probably due to the works nearby. There are no logos between the zebra tails across the junction (although shown on the drawing) and the north east corner has not been built out. If the zebra crossing is moved closer to Tapper Walk then a coloured cycle track with logos could be marked across the junction.

The bus stops north of Brewery Road, opposite Canal Reach and south of Bingfield Street are simple 'ride round' bus stops which are supposed to be marked with cycle logos as in [Figure 15](#) and [Figure 16](#) but *missing* in [Figure 4](#). We would prefer SUBBs but understand that Islington Council is wary of using them.

Figure 4. Opposite Canal Reach.
The works accessed via Canal Reach have prevented this junction from being treated.

Bus stop opposite Canal Reach. This 'ride round' bus stop should have logos marked.

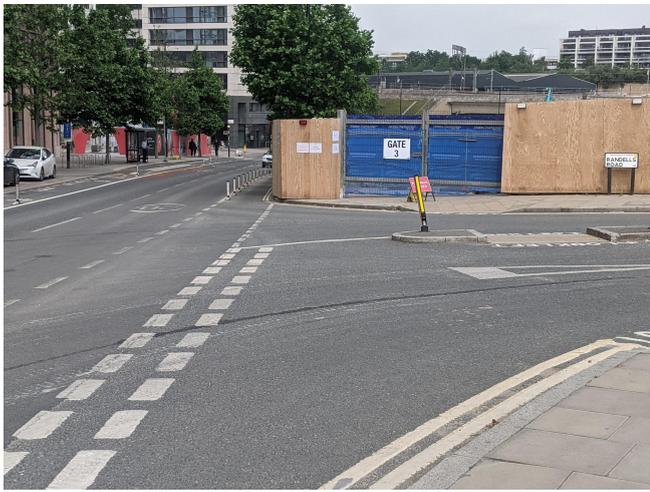
The cycle track across the junction with Randell's Road needs logos to be painted and the corners need tightening to ease crossing for pedestrians as well as cyclists and to slow down motor vehicles entering and leaving. See [Figure 5](#).

Figure 5: Randell's Road junction

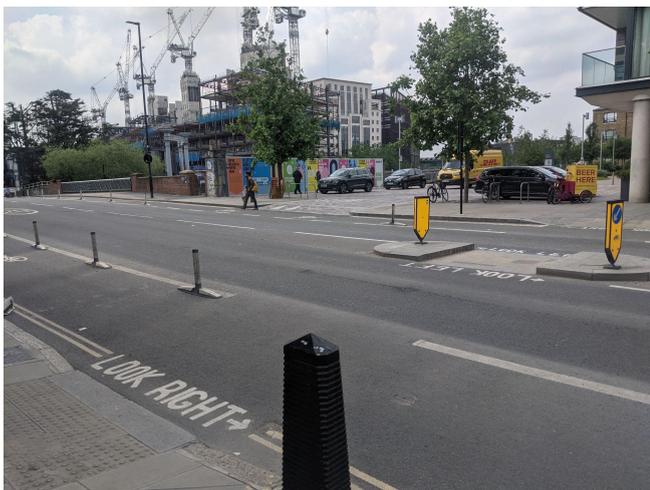
The pedestrian need is served by an informal crossing over York Way with a central refuge island. See [Figure 6](#). But it is hard for southbound cyclists to turn right into this route to Granary Square. We suggest either making a cycle refuge in front of the pedestrian island (as at Tapper Walk) or considering the possibility of a Tiger crossing.

Figure 6. The way to Granary Square is on the far side. The pedestrian crossing and refuge are in the foreground.

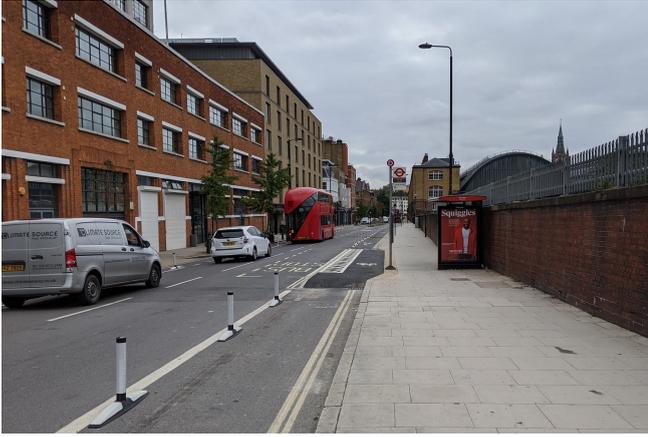
At this location there is a 'ride round' bus stop on the southbound side and a SUBB on the northbound track ([Figure 7](#)). We believe that there is room to implement bus stop bypasses on both sides of the road. The carriageway is 8m wide while:

South of Goodsway: the road is narrow here but the cycle tracks have been fitted in and the SUBB inset neatly in the footway edge. See [Figure 7](#).

The road is narrow here but the cycle tracks have been fitted in and the SUBB inset neatly into the footway edge (see [Figure 7](#)).

Figure 7. SUBB south of Goodsway. Note that the SUBB is inset a little into the footway to compensate for lack of road width.

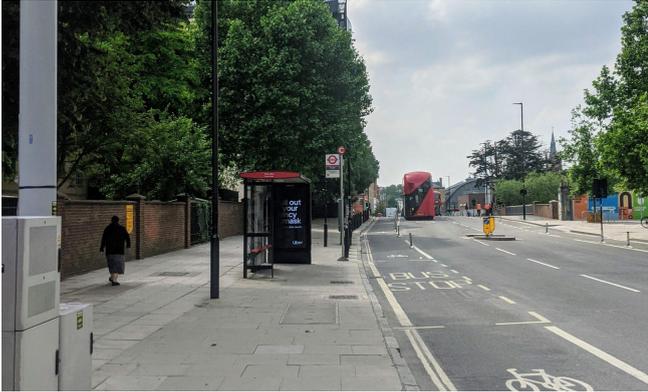
- The footway on the southbound side is about 7m wide, leaving plenty of room to make an island. See [Figure 8](#).
- The footway on the northbound side is about 6m wide, leaving plenty of room to make an island. See [Figure 9](#) and also this [StreetView](#).

Figure 8. Bus stop north of canal bridge.

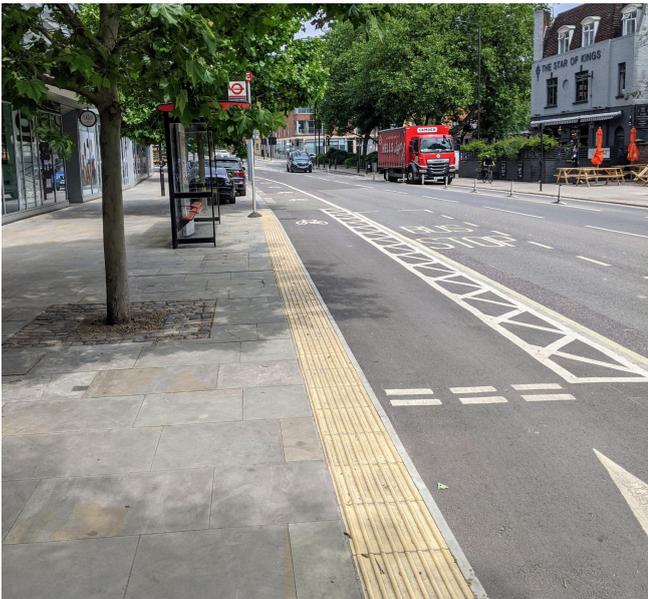
Figure 9. SUBB north of canal bridge.

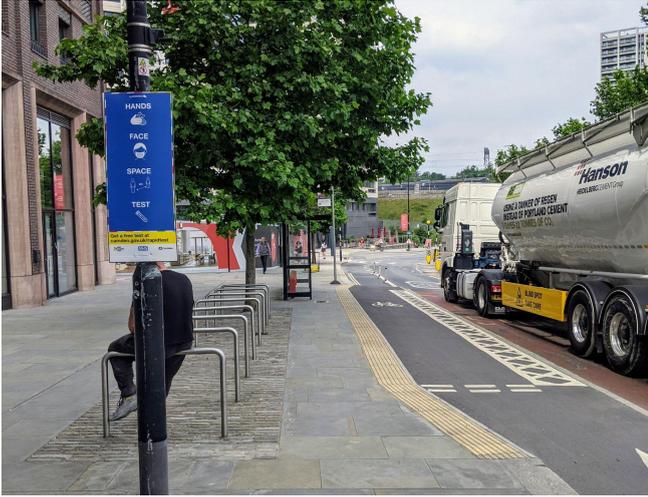
See [Figure 10](#). We believe that there is room here for a bus stop bypass. We also note that Camden has consulted on a bus stop bypass here (scheme drawing for bus Stop F). We encourage them to implement it!

Figure 10. SUBB south of Tapper Walk

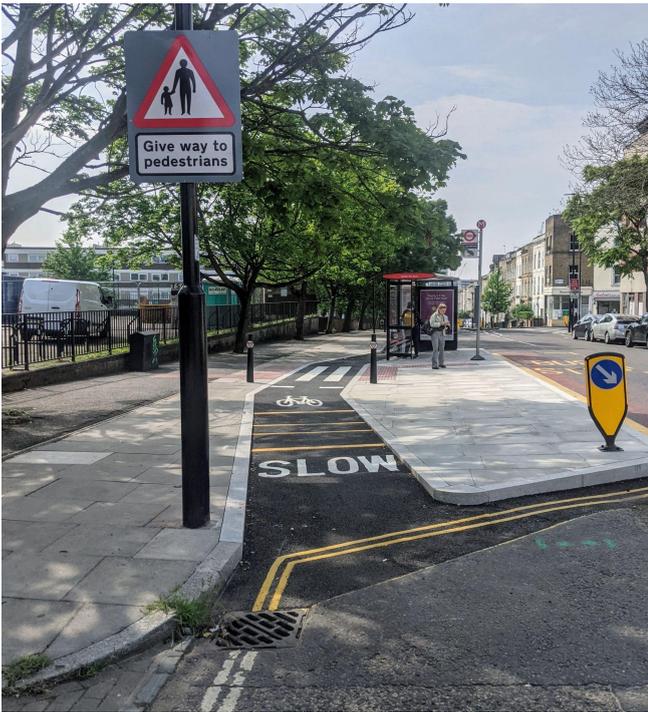
This bus stop bypass (built by Islington Council) is very generous in width with a 3.5m island. It has differences from those constructed in Camden, in particular the sign 'Give way to pedestrians' and the yellow rumble strips. Are the rumble strips part of a new standard intended to further encourage cyclists to slow down? If so we would be supportive as long as there is evidence that they are effective and do not cause any issues for disabled cyclists. The double yellow lines should not cross the track. See [Figure 11](#).

Figure 11. Bus stop bypass on southbound side north of Market Road.
Note the “Give Way to pedestrians” and the ‘rumble strips’. The double yellow lines should stop before the island and not cross the cycle lane.

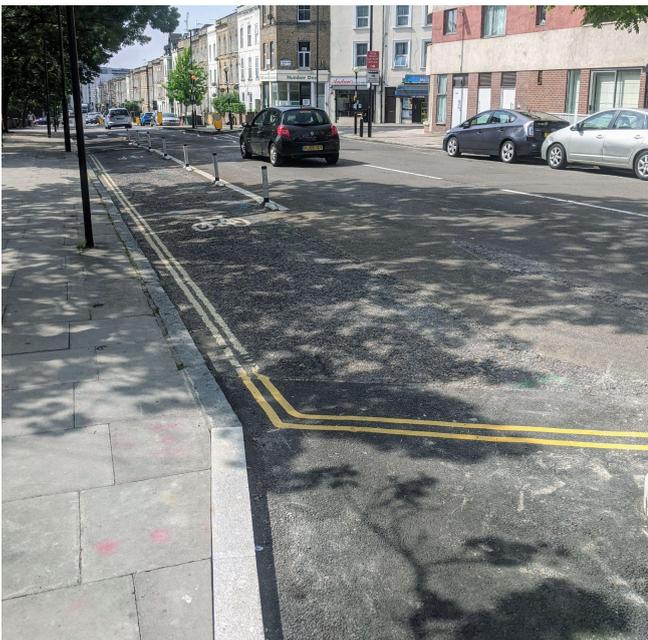
Track continuity south of the bus stop bypass: The outside of the cycle track should be marked with a line that meets the mandatory cycle lane where the bollards are installed. The double yellow lines should not cross the track. See [Figure 12](#). This photo also shows the track approaching the zebra by Camden Park Road whose alignment is good.

Figure 12. Track continuity south of Bus Stop bypass. As the track cycle continues south it should be marked and supplied with bollards. The double yellow lines across the cyclists’ path should be erased.

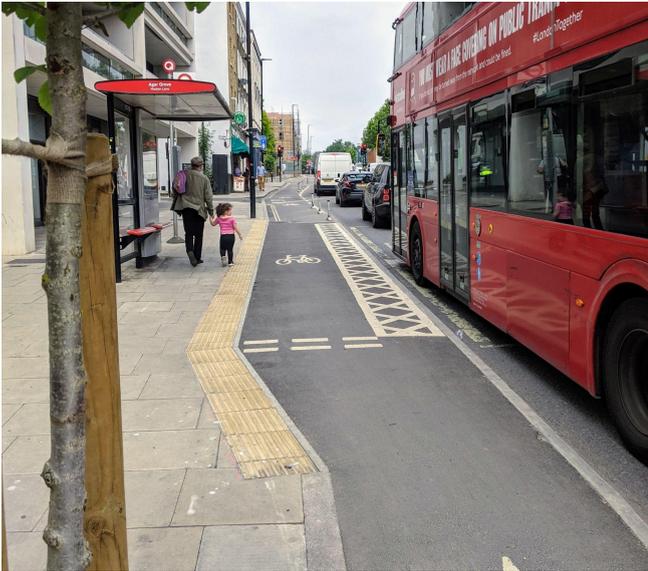
South of Agar Grove (outside the Maiden lane estate) [Figure 13a](#) and [Figure 13b](#) and *south of Market Road* [Figure 14a](#) and [Figure 14b](#).

Figure 13a. Maiden Lane SUBB.

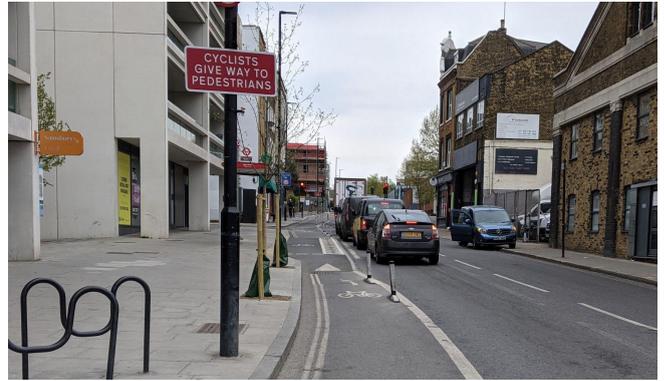
Why do only these two SUBBs have red signs warning cyclists to give way to pedestrians?

Figure 13b. Maiden Lane SUBB with "Cyclists Give Way to Pedestrians" sign.

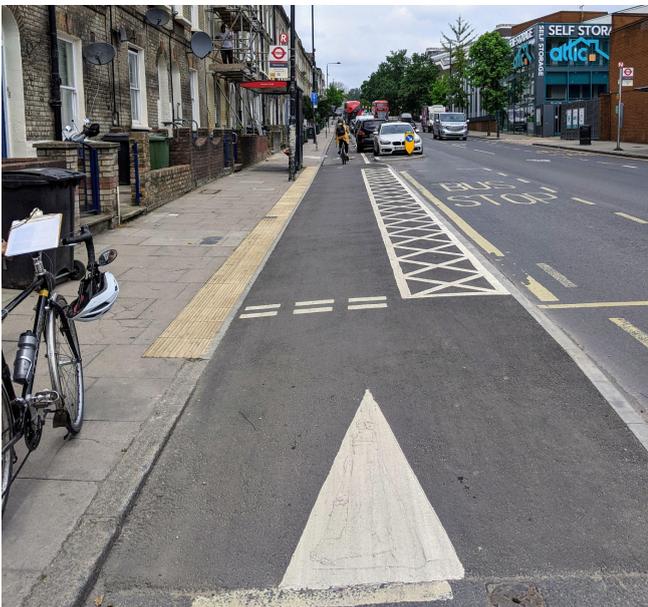
Figure 14a. Brewery Road SUBB

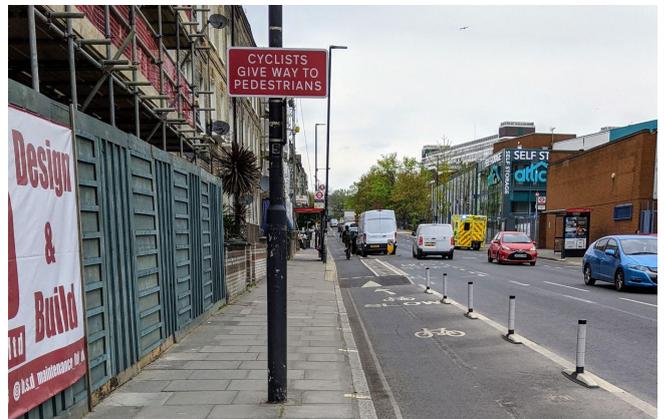
Figure 14b. Brewery Road SUBB with "Cyclists Give Way to Pedestrians" sign.

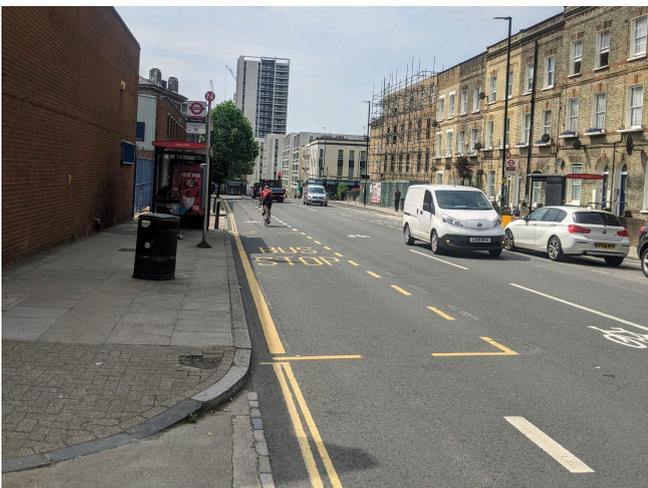
Figure 15. Bus stop north of Brewery Road. See the logos indicating that cyclists can ride round if a bus is in the cage.

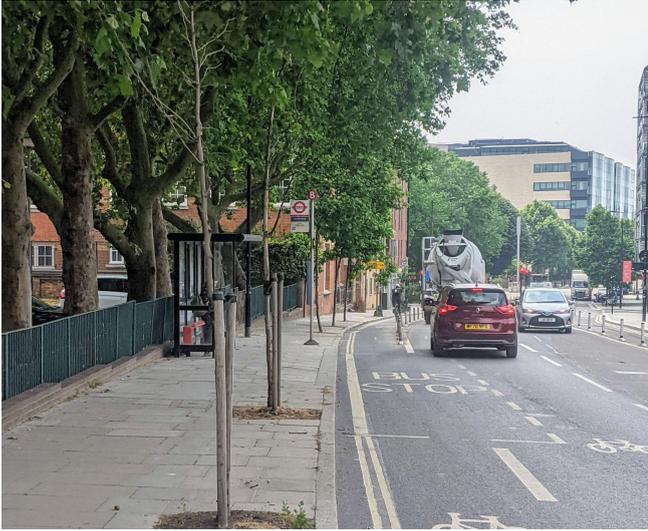
Figure 16. Ride round bus stop south of Bingfield Street

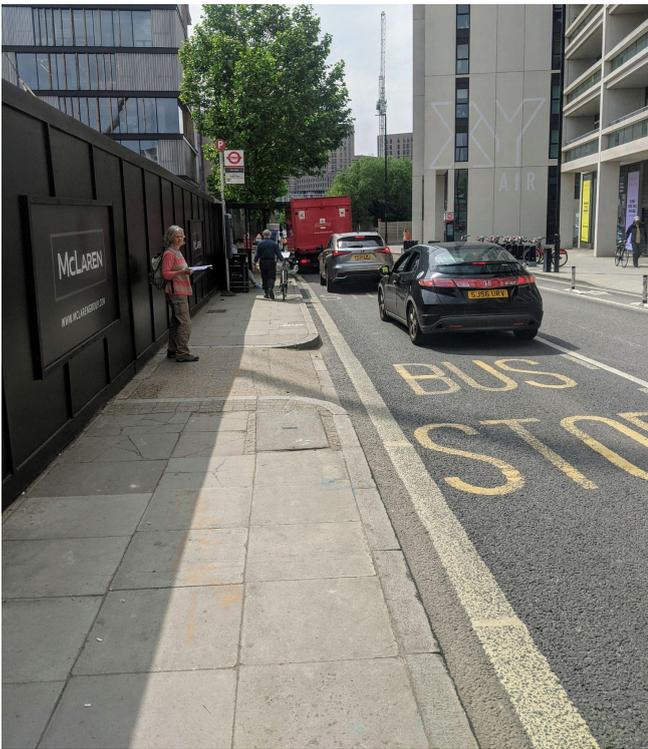
The bus stop between Brandon Road and the Overground bridge in [Figure 17](#) is in a very narrow section of road where there is no room for a cycle lane and hence no SUBB - not even the idea of 'riding round'.

- The Phase 2 drawing shows cycle logos but these have not been painted on the road.
- Loading is allowed between Brandon Road and Tileyard Road (10 am to 4pm [Figure 17](#)) specifically for Kings X motors but can be used by anyone (according to the Phase 2 officers report Section 2.8).

This section is the 'weakest link' in the entire route. People cycling on this alignment have no feasible alternative so all efforts should be made to keep the kerbside clear.

Figure 17. The very narrow stretch of road between Brandon Road and the south side of the railway bridge. The bus stop necessarily has no 'ride round' markings. But it is unforgivable that loading is allowed in this section. Without loading cycles can generally use the kerbside gap to undertake the motor vehicles..

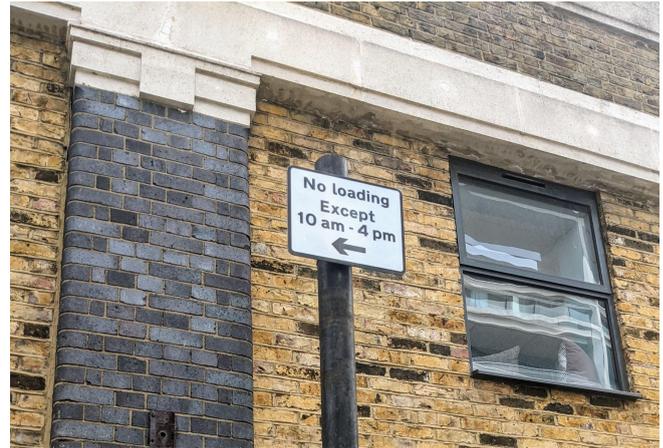
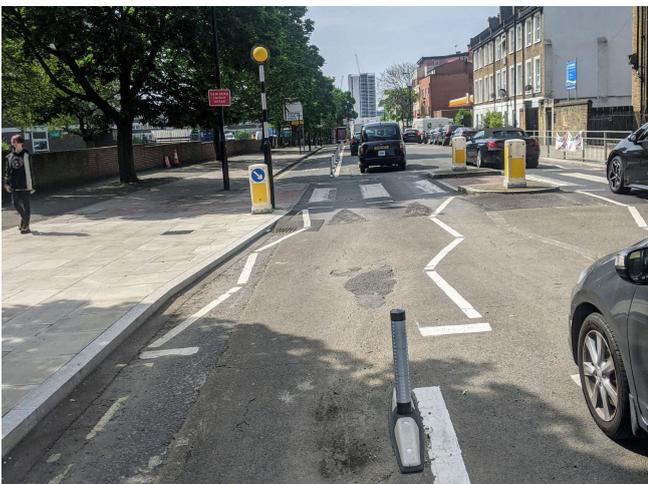
The alignment of the kerb from North Road is strange in that cycles have to move out on approach to the build out for the zebra crossing. [See Figure 18](#). The Phase 2 drawing shows a footway build out which appears to be missing. The ramp up to the zebra should be marked with a triangle (the photo shows that triangles have been burnt off).

Figure 18. Raised zebra with chicane outside Brecknock Primary School.

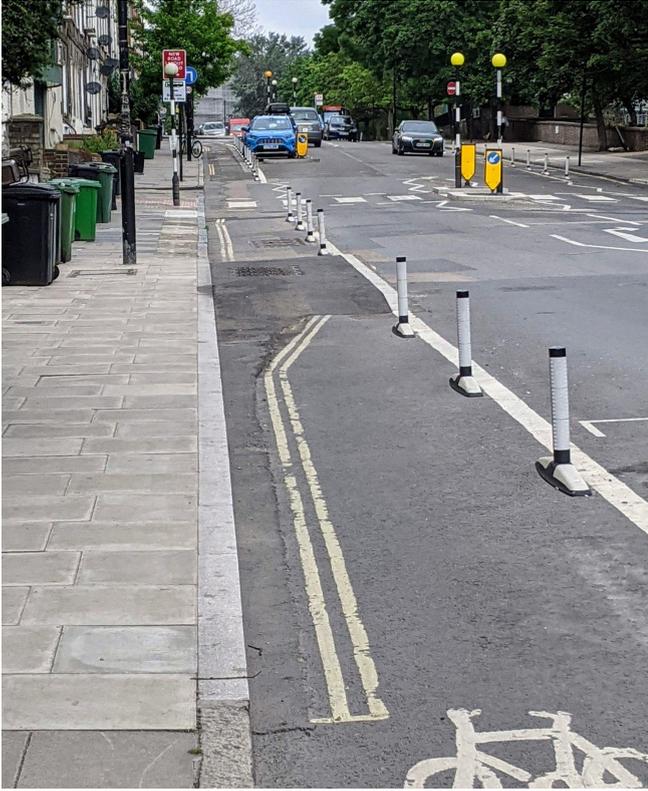
We like zebra crossings to have short tails followed immediately by bollards as for example, the zebra close to Market Road [Figure 19](#) and the zebra close to Bingfield Street [Figure 20](#) and we would like this to become general practice.

Some extraneous double yellow lines need to be repainted on the approach to the stepped track opposite Market Road. See [Figure 19](#).

Figure 19: Poorly positioned double yellow lines on approach to the stepped track opposite Market Road.
But the zebra here is good: short tails followed immediately by bollards.

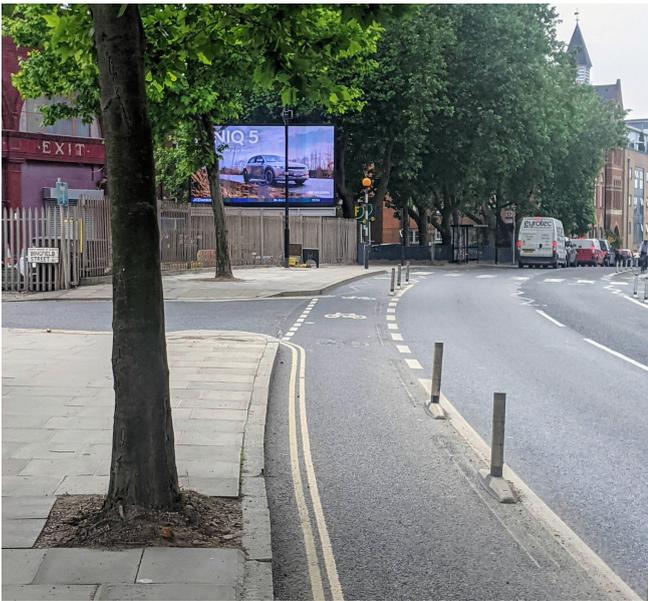
Figure 20: The zebra crossing south of Bingfield has short tails. We like this.

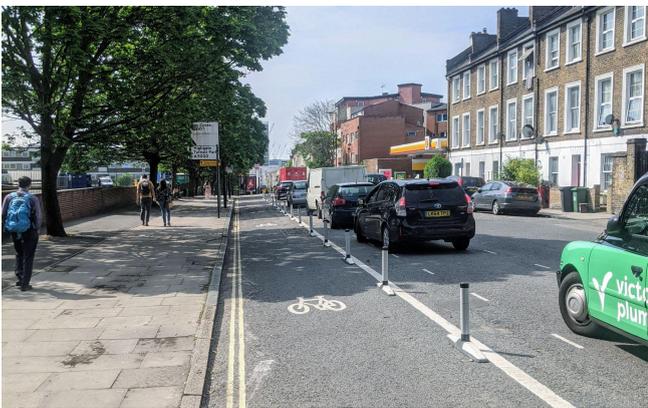
The width of the cycle track and the buffer between the track and the parked cars is good but the road surface is poor. See [Figure 21](#).

Figure 21. South of Brecknock School

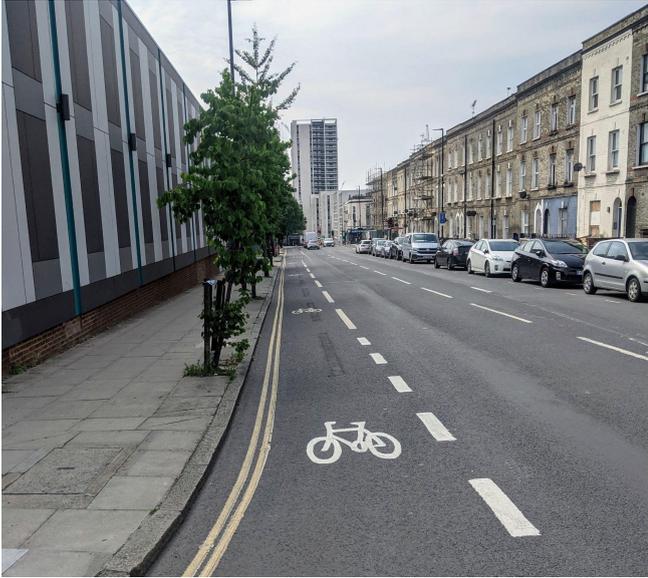
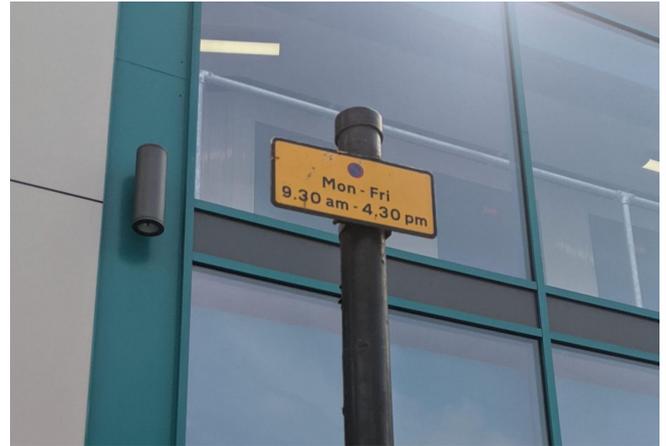
See the southbound video from 2:08 - 2:16. Here we have a long stretch of advisory cycle lane almost as far as Brewery Road. We strongly object to this section of advisory cycle lane and propose that it should be replaced by a mandatory lane with bollards. We have consulted the Phase 2 officers report Section 2.9 and note that loading space for a self-storage company is being provided. But we think this should be removed when the use changes to residential and, in any case, we question the need for such a long break in the protected cycle lane. The sign is inappropriate in that it says No Parking from 9:30am - 4:30 pm. See [Figure 22](#).

Figure 22. Advisory Lane south of Market Road. The prohibited hours when parking is prohibited seem wrong!

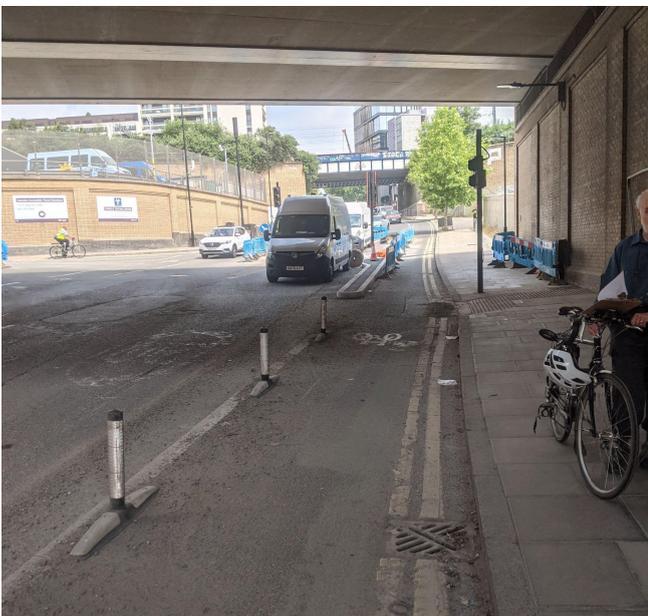
This section of road suffers from the spillage from lorries leaving the Freight Lane ready-made concrete works. It looks as though the road is swept regularly but not the cycle track. Could the concrete company be persuaded to organise cycle lane cleaning?. See [Figure 23](#).

Figure 23: This section of road suffers from the spillage from lorries going to the Freight Lane ready-made concrete works. It looks as though the road is swept regularly but not the cycle track.

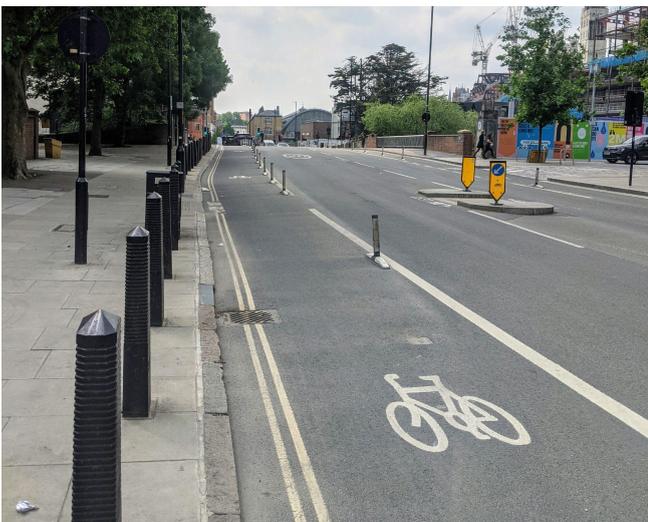
These first appear south of Copenhagen Street and re-appear by the canal bridge and again between King's Place and Wharfdale Road. They were probably put there to stop people parking on the footway, for which they are no longer relevant. We would prefer to have them removed. See [Figure 24](#).

Figure 24. Black bollards

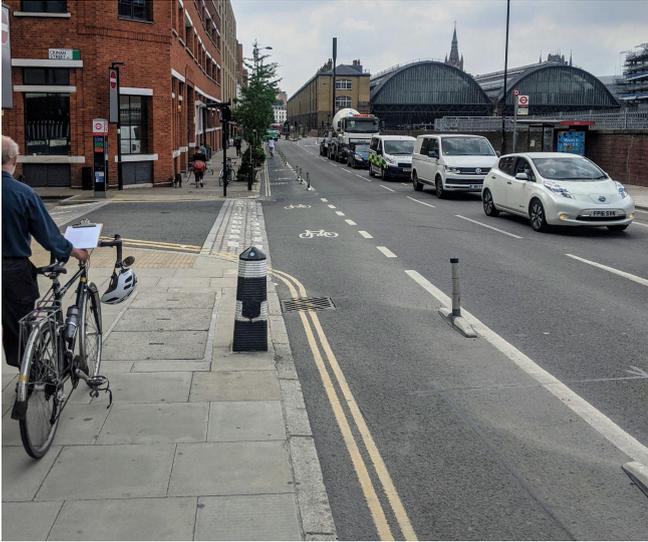
The cycle tracks here are good, mostly above 2m in width. See [Figure 25](#). While we were here, we had a chat with a resident of Wharfdale Road who mentions the need for two-way cycling on that road. Please ask Islington officers about this. Whenever that is achieved, then the junction with York Way will need a big upgrade!

Figure 25. Looking south from Kings Place towards the Wharfedale Road junction.

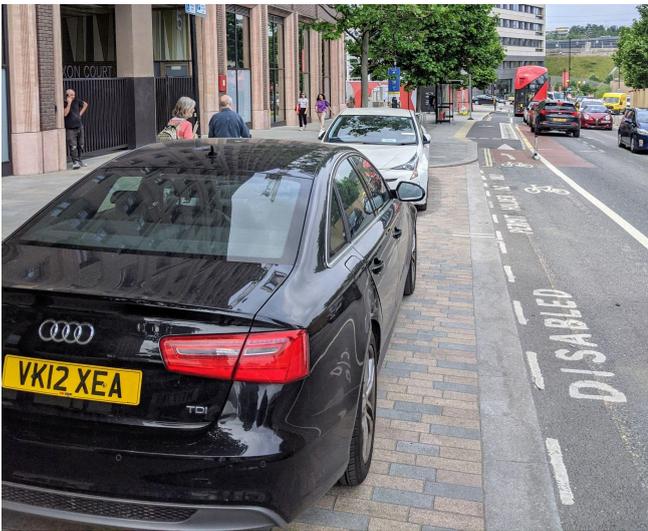
We inspected the disabled and motorcycle parking bays near Handyside Street as well as another disabled bay near Beaconsfield Street. See [Figure 26](#). This inset parking is set well back from the cycle track and seems not to cause any problems.

Figure 26. The photo on the left shows inset disabled parking south of Copenhagen Street. The adjacent motorcycle parking is shown below. There is another disabled bay near Beaconsfield Street.

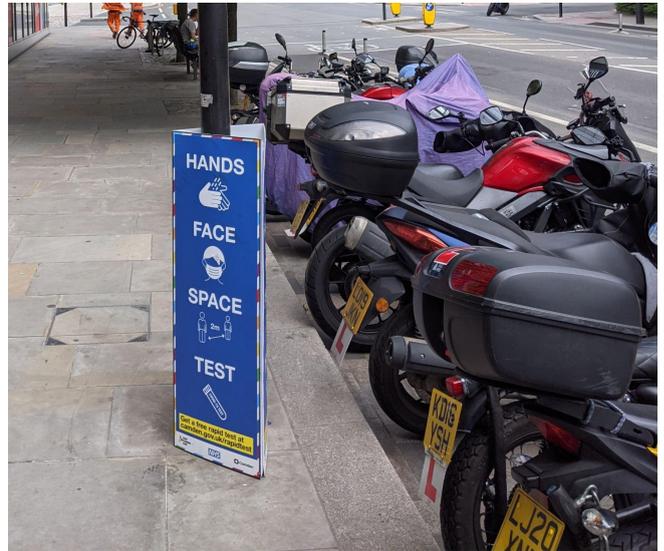
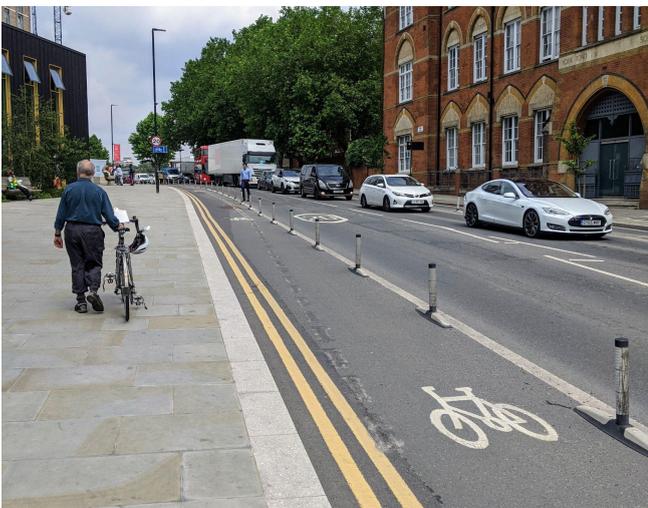
[Figure 27](#) shows the northbound track after Handyside Street. It is well above 2m in width until it narrows opposite the ride round bus stop south of Bingfield Street. The next section of track is very narrow (1.5m) on both sides of the road while the motor lanes have 6.5m.

Figure 27. The northbound track north of Handyside Street

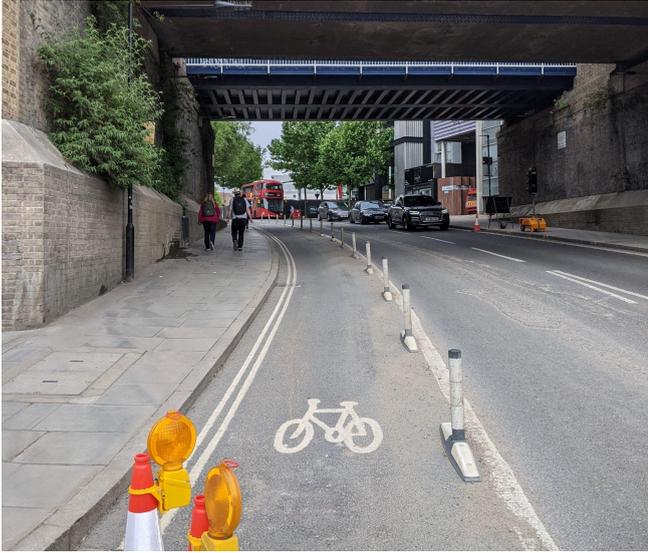
Another very dirty stretch of cycle track. See [Figure 28](#).

Figure 28. The northbound route continues under the railway bridge. This is another very dusty stretch.

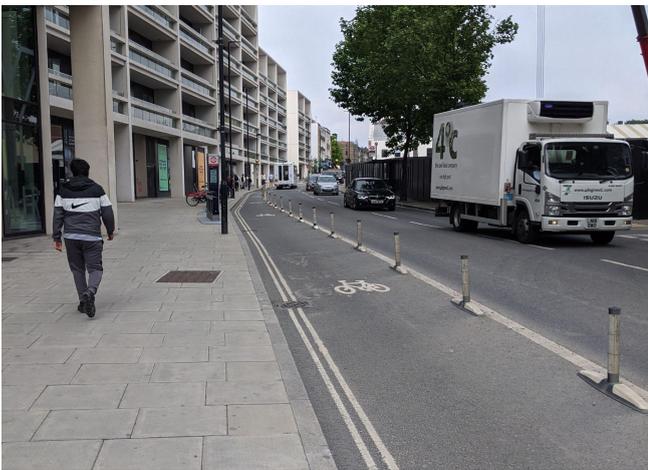
The northbound track is shown in [Figure 29](#). This is the narrow section of York Way where there is no southbound track.

Figure 29. The northbound track passes Vale Royal

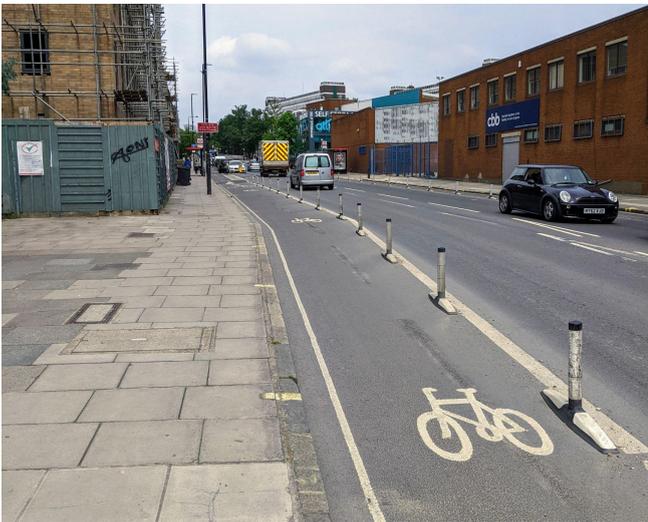
[Figure 30](#) shows single yellow lines and single blips inside the cycle track whereas they are normally double.

Figure 30. Cycle track north of Agar Grove
