# Review of cycling infrastructure around the Swiss Cottage Gyratory

Camden Cyclists (by Kaveh Kordestani), July 2025

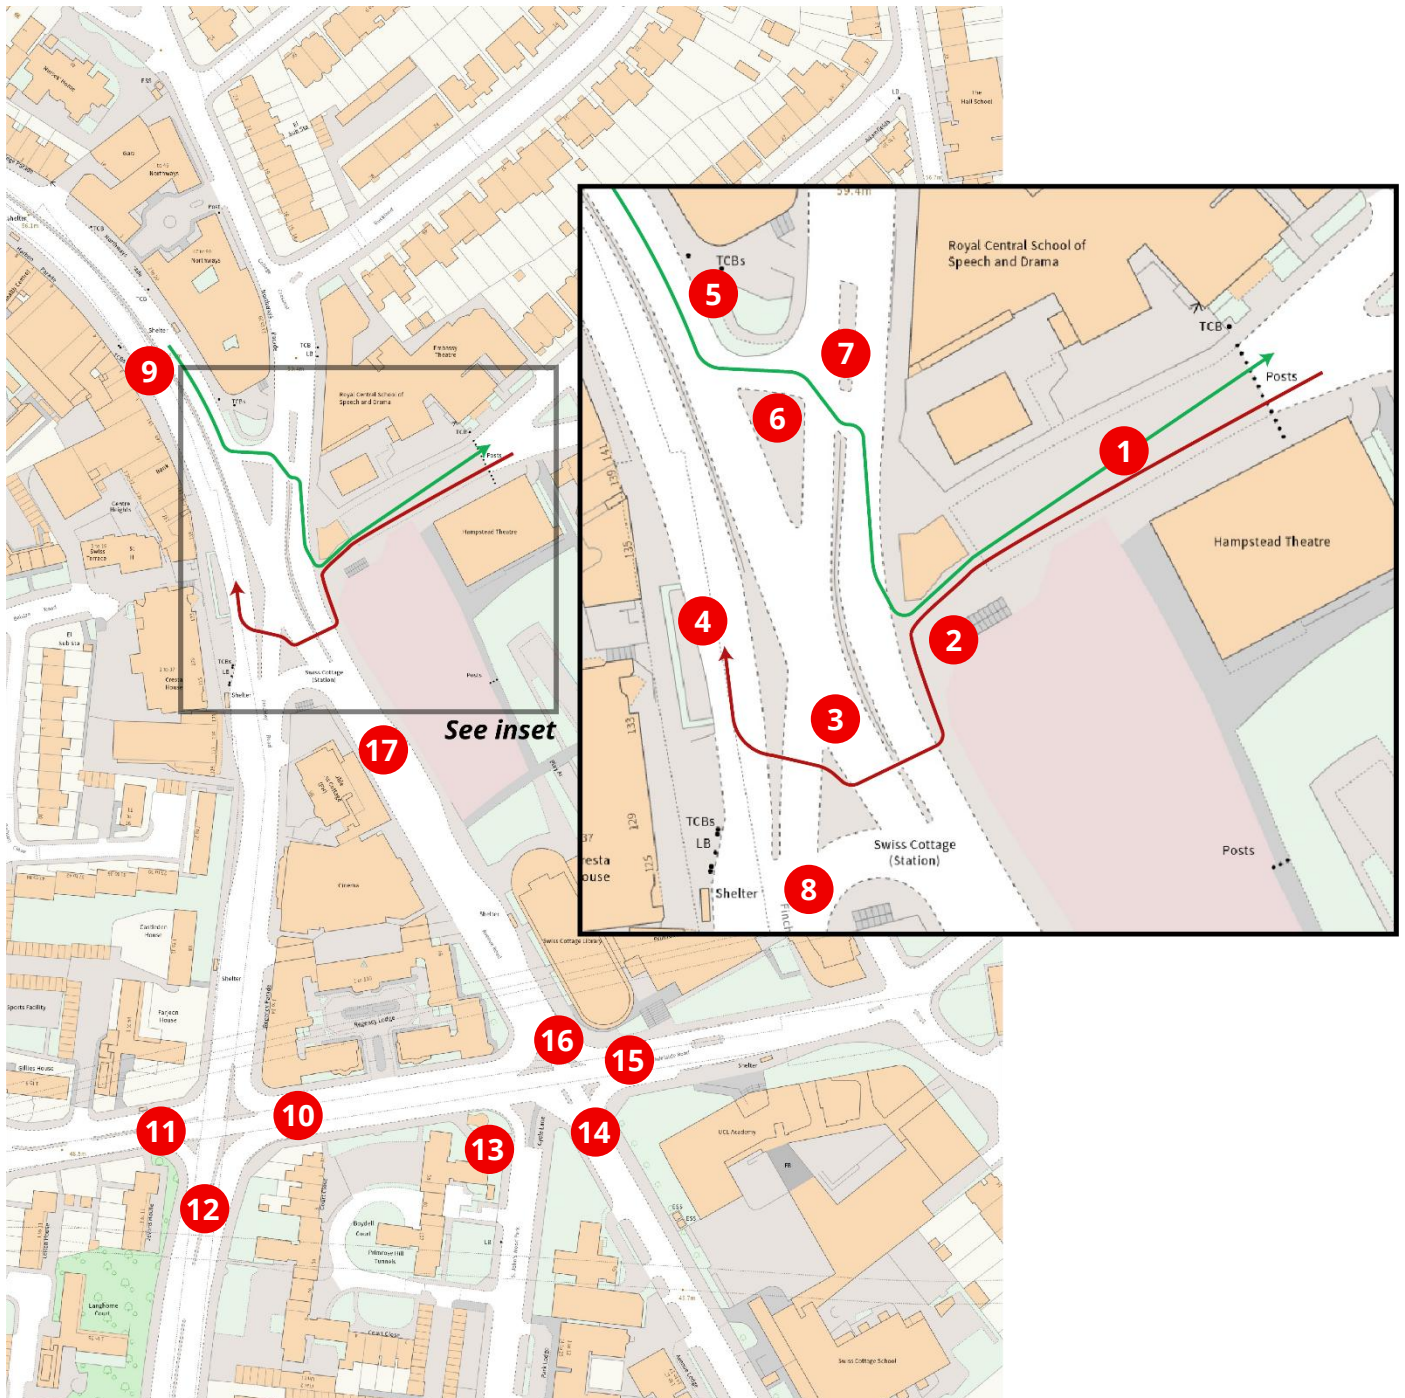
## Overview map

The dedicated cycling infrastructure from Eton Avenue is highlighted in red and green.

- At **2** there is a separate cycleway.
- Fig 2.1 shows its very poor condition. Many of the paving stones have been rearranged and the markings have not been reapplied.
- Fig 2.4 shows where the paving changes. The green has faded greatly and is less evident to pedestrians.

- **Recommendation 1:** the cycleway at **2** should be realigned to be closer to the tube entrance to provide sufficient separation. It should also be repaved and remarked.
