Audit of Haverstock Hill cycle tracks

Camden Cycling Campaign, report on audit carried out at 1PM on 11th July by committee members: John Chamberlain, Paul Allen, Steve Prowse, Elena Moynihan

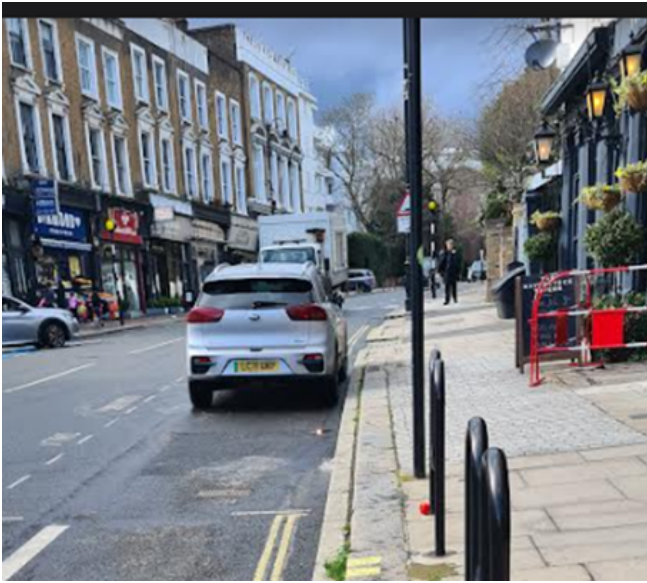
Figure 1: Cars parked outside the Haverstock Tavern in the loading bay which doesn't have a sign

This bay is regularly abused by the local businesses for parking their vans throughout the day and by customers of the pub in the evening or during the day. This section of the lane is nearly always obstructed this way.

Also, the signage stating the restricted areas was removed months ago and has not been replaced.

These loading bays are often being abused. We suggest that Parking signs are added to the main road informing drivers that there are some pay-by-phone spaces on the side roads.

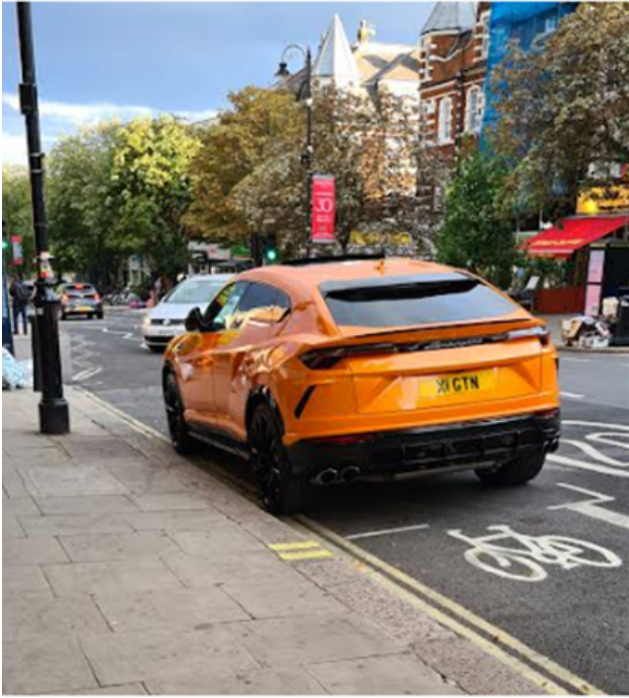
Figure 4. Cars parked in Belsize Park loading bay whilst customers shop or drink in cafes in Belsize Park

This bay is regularly abused by vans parking and customers of Pret and other establishments

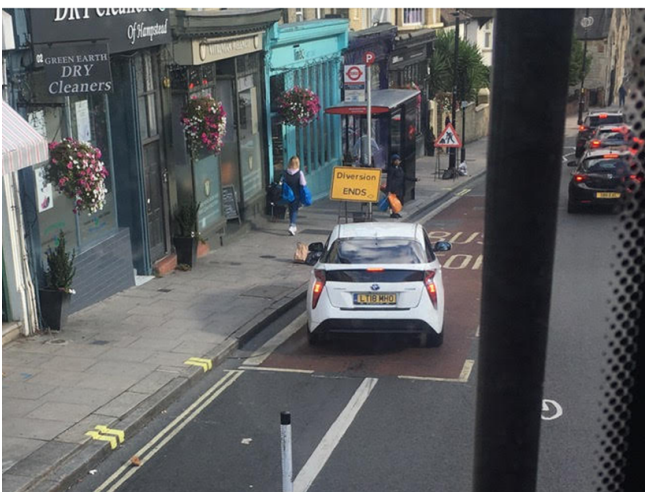
Figure 6. Cars idling and parking in the sections next to the Southbound bus stop between Steele's Road and Eton Road.

The current configuration of the southbound route bus stops generates a considerable number of breaks in the flow: these are also abused by vans and cars parking near the bus stop. See [Figure 6](#).

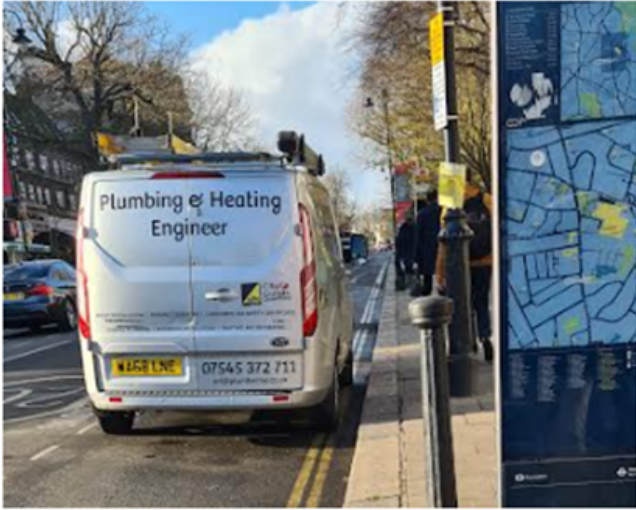
Figure 7. Vans using the double yellow line adjacent to bus stop in Belsize Park southbound to park

The large gaps at each end of the Southbound bus stops are used by cars and vans to stop, idle and park. See [Figure 7](#) and [Figure 8](#).

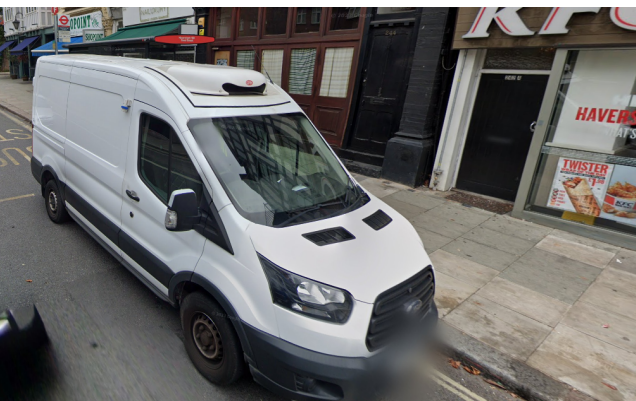
Figure 9. From Google Maps, an example of vans parked outside KFC

Break for Southbound bus stop regularly used by vans, delivery bikes and cars to park. See [Figure 9](#).

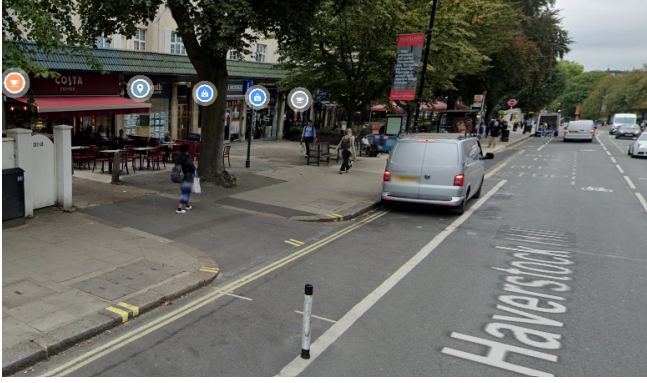
Figure 10: From Google Maps, an example of vans and cars parking by the slip road outside Costa

This used to be a loading bay. The loading bay has been replaced by double yellow lines which are frequently abused and still used for loading and parking.

This double yellow line section needs to be incorporated in the segregated cycle lane

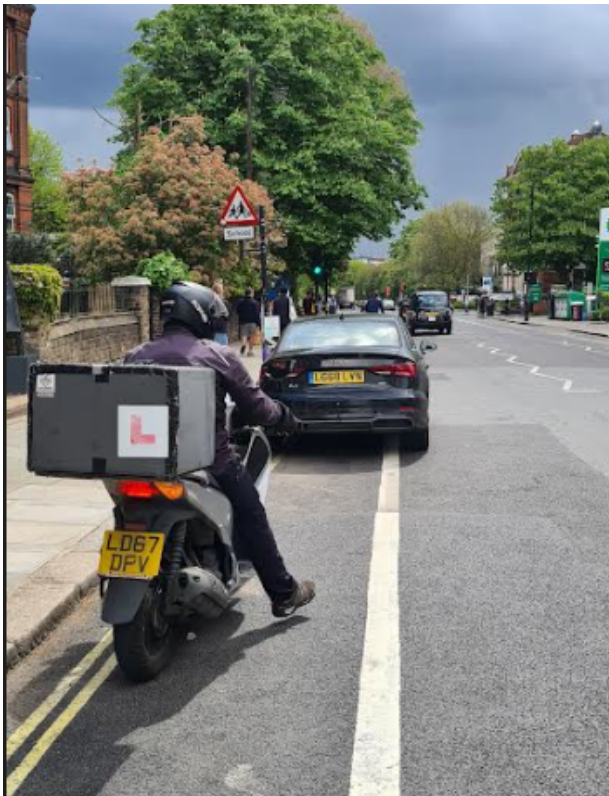
Figure 12.
Cars parked on break of cycle lane.
One of the several scooters often parked or idling to pick up outside KFC.
Friday 5th of May, 11:50AM

Adjacent double yellow lines regularly used by vans, cars and delivery scooters blocking the lane.

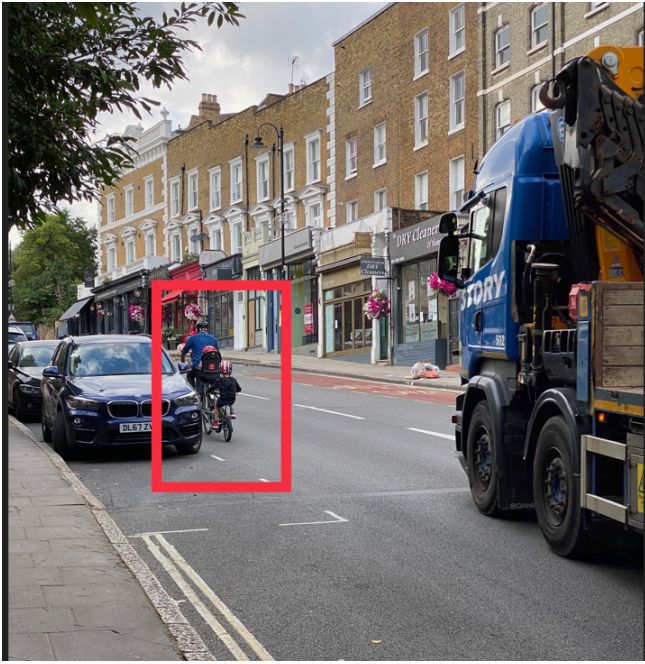
Figure 13.

An example of children riding in Haverstock Hill prior to the cycle lanes.

Bikes had to swerve in the traffic to avoid parked cars and share the road with heavy traffic and lorries

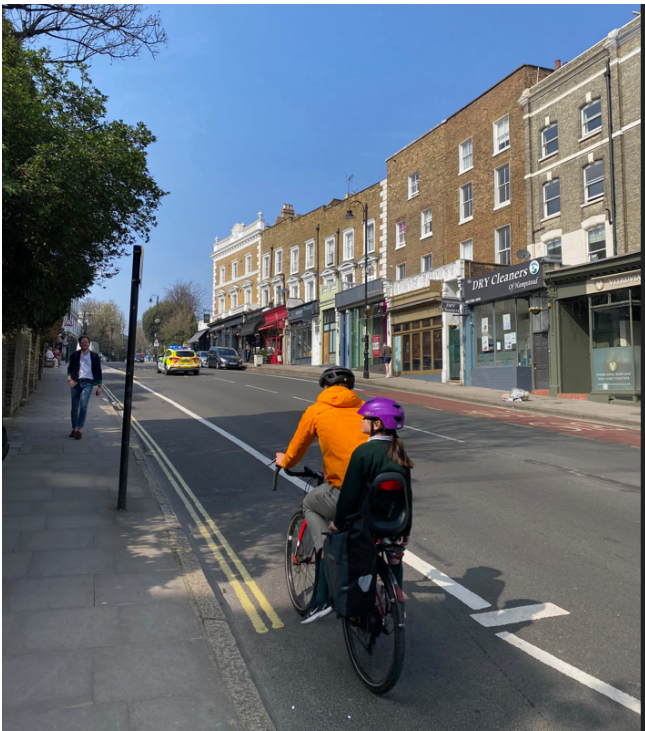
Figure 14.

- The cycle lane has vastly improved the safety and quality of cycling on the northbound side. See [Figure 13](#) and [Figure 14](#) for two examples of before and after. It is now much safer and pleasanter to ride, particularly with families and small children in tow. The lane is regularly used by people on traditional bikes, Lime bikes, e-scooters and cargo bikes. See [Figure 20](#)

An example taken in the same spot as Figure 13 using the bike lane

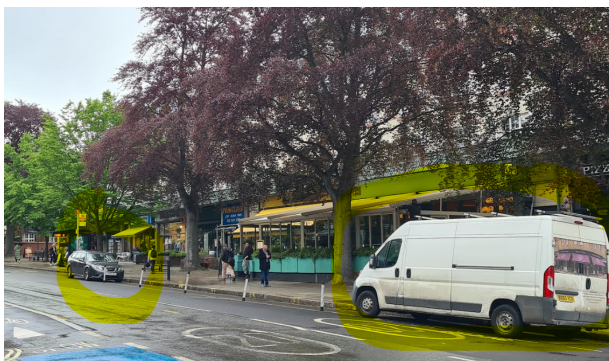
Figure 15.

The cycle lane is squeezed between a Bus Stop and a loading bay. Both allow cars and vans to be illegally parked at each end, effectively blocking the lane. See [Figure 15](#)

An example of car parked at the top of the lane and a van at the other end, this combo effectively blocks the lane completely (11th May at 2PM)

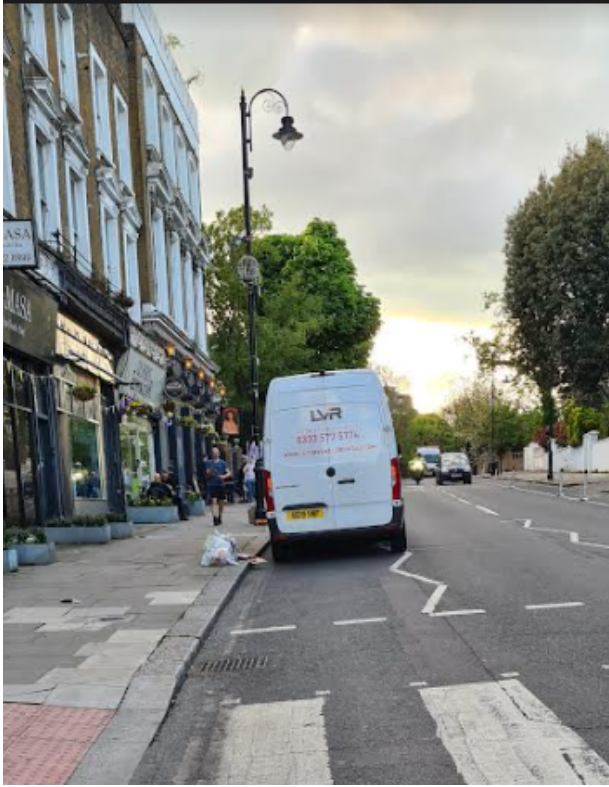
Figure 16

The area surrounding this crossing (zig-zags) is routinely used by vans belonging to the shops to park and load . See [Figure 16](#).

Two of the cycle wands have been vandalised to allow parking outside the shops.

An example of a van parked on the zebra zig-zags outside the shops in Steeles village.

- There are some sections of cycle lane with double yellow lines currently not segregated by wands, these should be all incorporated in the lane and segregated from traffic as they are now regularly used as parking and loading opportunities. Camden should also look at shortening some of the zig-zags at the before and after zebra crossings to reduce the opportunity for parking there.

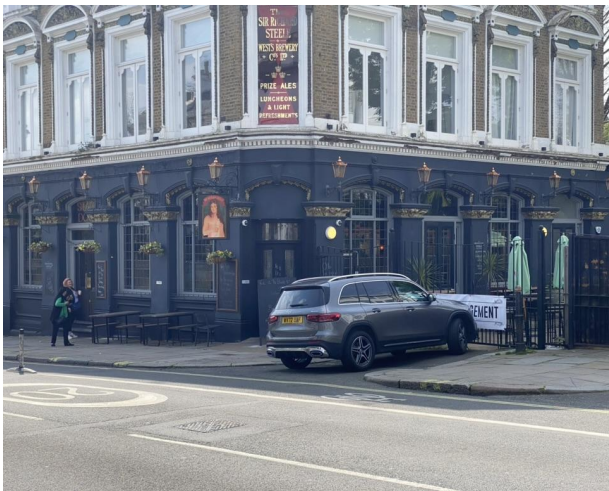
This driveway is frequently used by cars parked to access the pub, blocking the footway. See Figure 19.

An example of a car blocking the footway at the Sir Richard Steele pub.

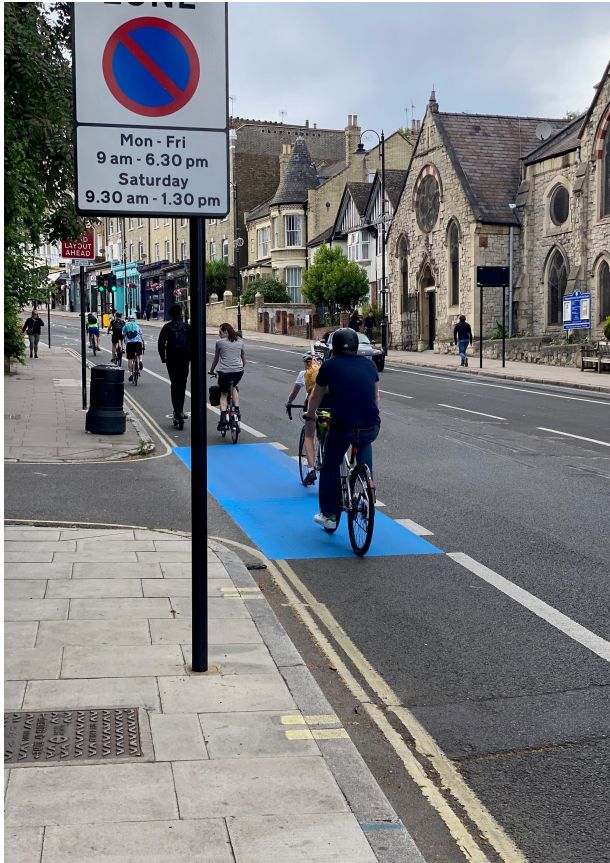
Figure 20.

An example of 6 cyclists and a e-scooter using the cycle lane on the first steep section that used to be particularly un-safe.

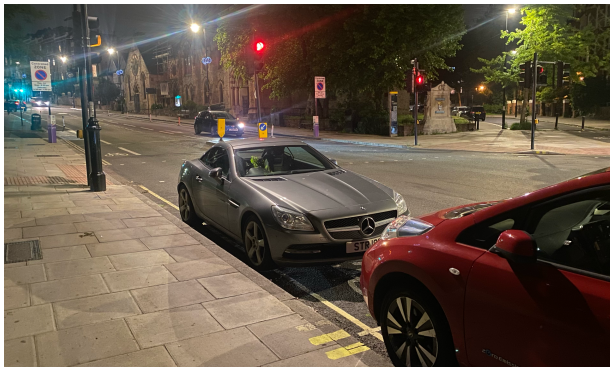
Figure 21.

There is a short section of single yellow markings (missing double yellow?) on the west side of the road at junction, see Figure 21 & <https://flic.kr/p/2oAjPJo>. This allows cars to park within the junction, which is dangerous for Northbound cyclists and also for vehicles using the junction.

An example of cars dangerously parked in the junction between Haverstock Hill and Prince of Wales Road, due to the short section of single yellow line.

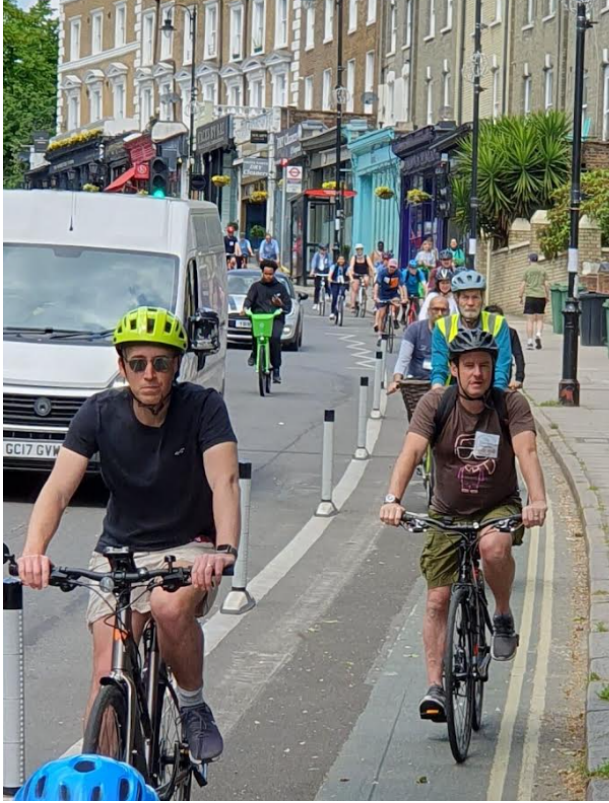
Figure 22

- However, the southbound lane is compromised by the large number of interruptions due to bus stops and, especially, loading bays, many of which are abused by long-term parking and parking outside of permitted hours. The zig-zag areas at each side of the several pedestrian crossings are also now used as an idling and loading opportunity. With no effective enforcement, this makes the southbound lane very unattractive to inexperienced riders or cyclists with children, and potentially dangerous due to the number of times cyclists have to merge with motor traffic. This lane when improved will be a big boost to encourage people who do not normally cycle to do so. See [Figure 22](#).
