CCC Audit of Midland - Judd, 21 May 2019

We walked and cycled the route in both directions between the junction with Pancras Road and the top of Judd Street.

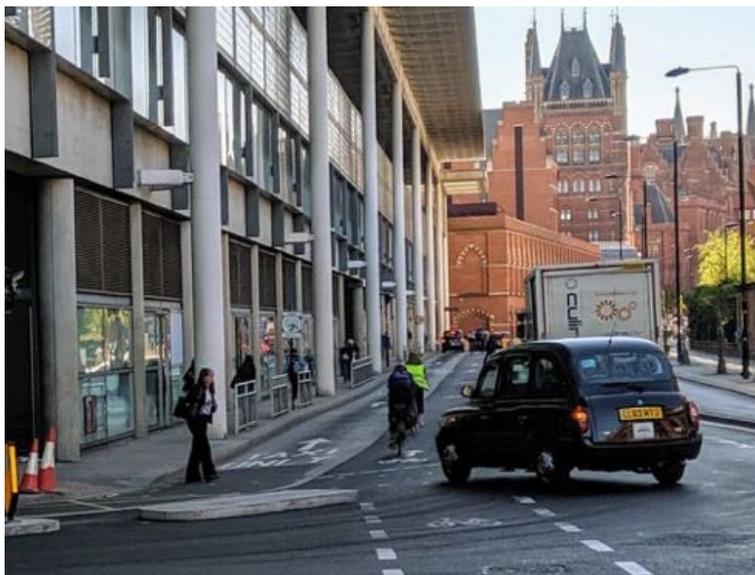
1. Taxi- cycle interactions

Taxis SB on Pancras Road entering the Midland Road taxi rank at the junction of Pancras Road have to cross the path of cycles.

With the former ASL and central feeder arrangement at the signals, taxis would have been inside cycles.

With the new layout, cycles are at risk of a left hook by taxis¹.

We have not been able to think of any solution to this problem.

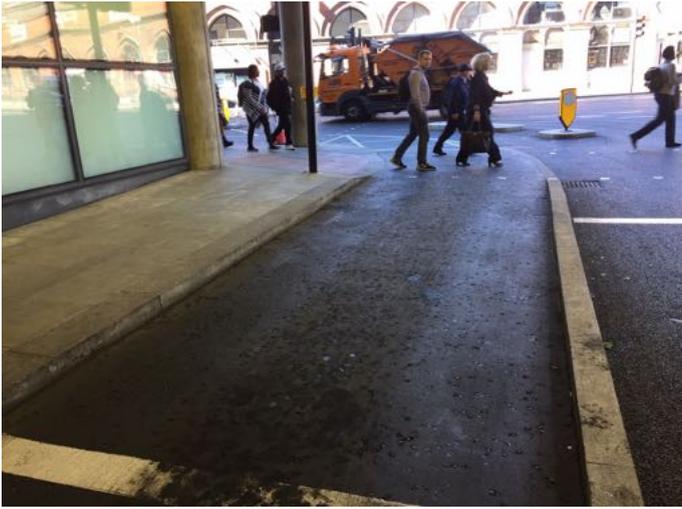
2. Critical failure at junction Midland Road/Pancras Road

Cycles emerging from the tunnel and needing to turn right are at risk of left hook from left turning motor vehicles.

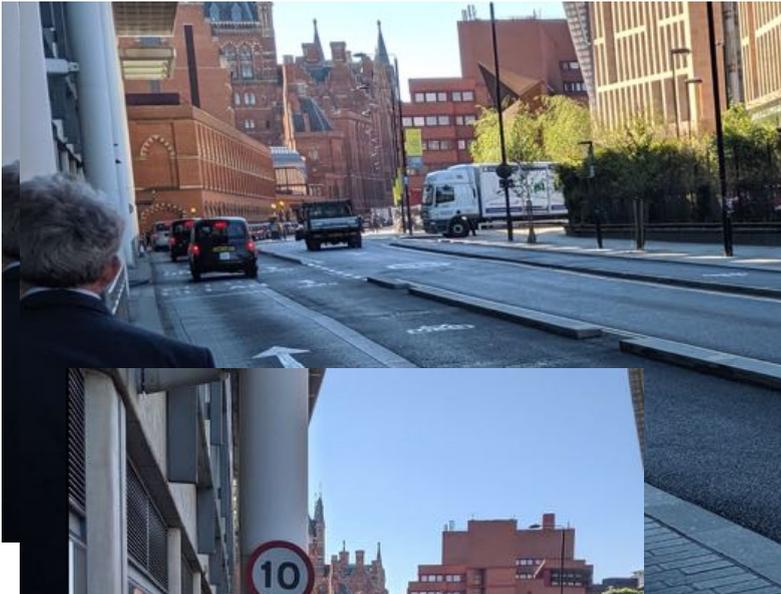
5. Unforgiving kerbs

The kerb stone separators on the SB cycle track have sharp corners. It would be much safer to have chamfered kerb stones (see #13 below).

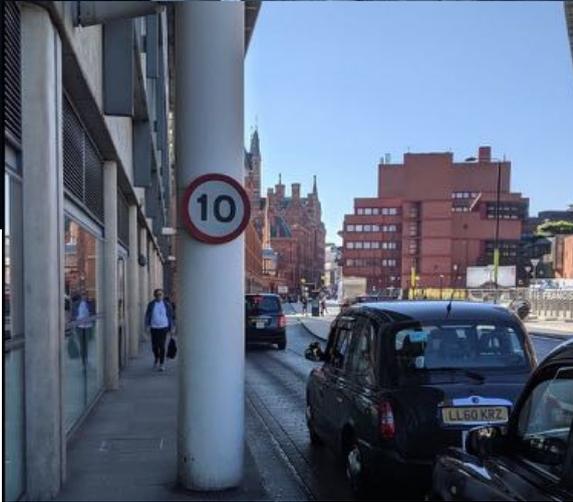
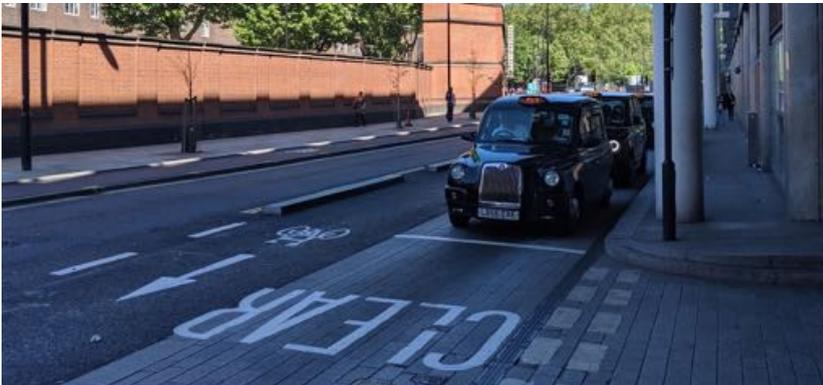
6. Issues from having the cycle track adjacent to the taxi rank.

- Some taxis were observed to encroach on the cycle track
- Some taxis were observed speeding down the taxi rank inside the cycle track

We suggest:

- a solid white line to demarcate the boundary of the cycle track, or apply paint to the large pavers separating the two lanes white.
- an additional 10 mph sign near to the top of Midland Road, similar to the existing one further down (photo).

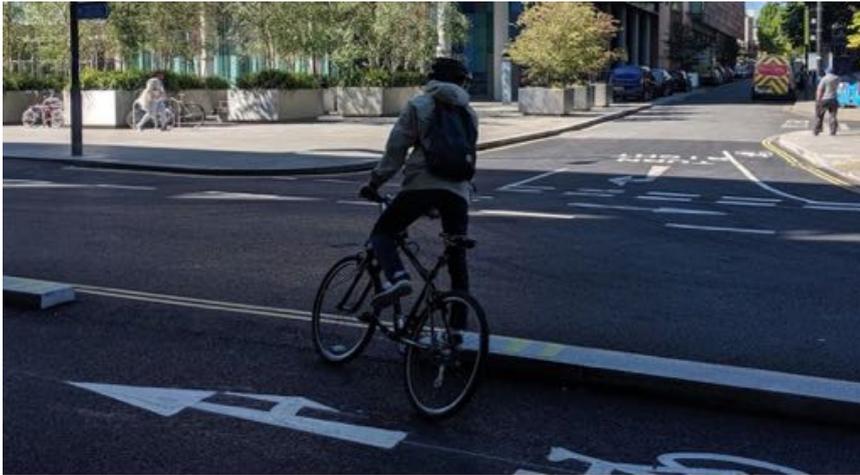
7. Exit from the coach park

Cyclists use this exit after leaving the station cycle park. This exit forms a much more satisfactory route to and from the cycle parking than from the Kings Cross side.

- a. We observed a cyclist turning right, but he was impeded by a kerb from entering the cycle track opposite. A dropped kerb is needed on the northbound track.

- b. The two steps for pedestrians are not up to accessibility standards.
- c. The stop line for SB taxis is too close to the exit, reducing visibility of cycles for emerging vehicles.
- d. See #21 below on signage of the cycle route for people with cycles emerging from the station

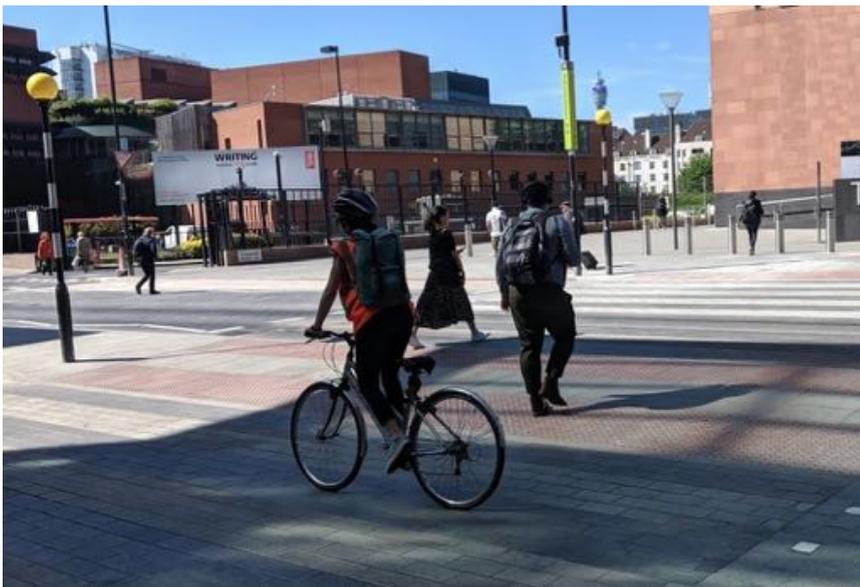
8. Right turn into Brill Place

The right turn into Brill Place is marked on the track, but there is nowhere to wait; also the same gap is used by people turning right out of Brill Place. The gap could be wider but shouldn't be wide enough for taxis to get in.

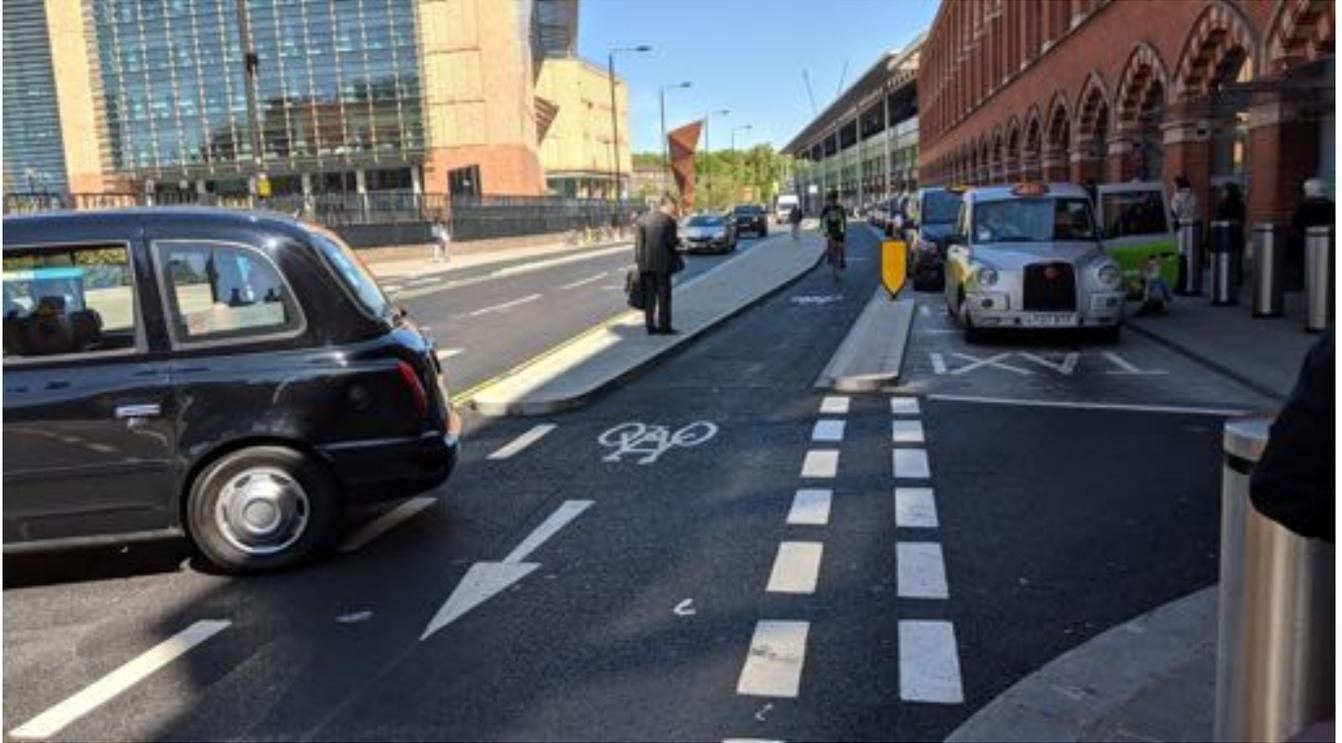
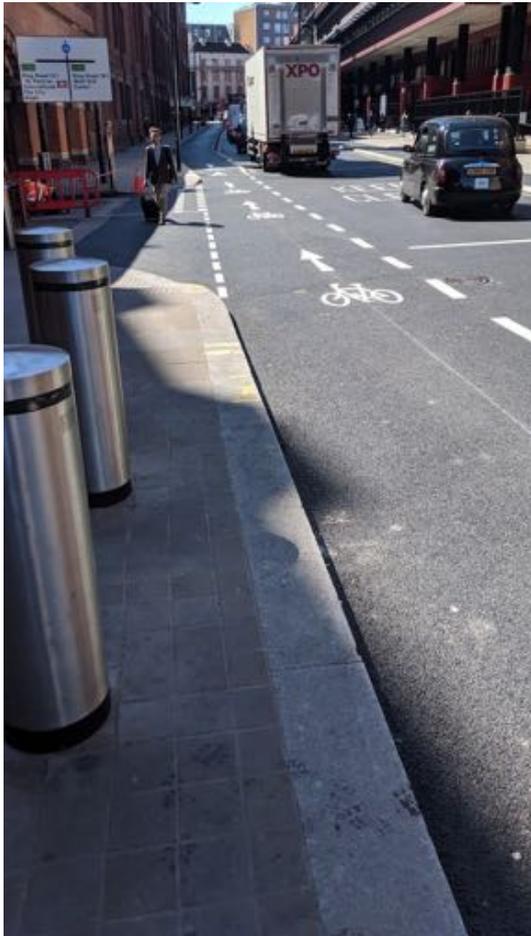
10. The crossover at the taxi pick up point

The crossover at the taxi pick up point seems to work reasonably well

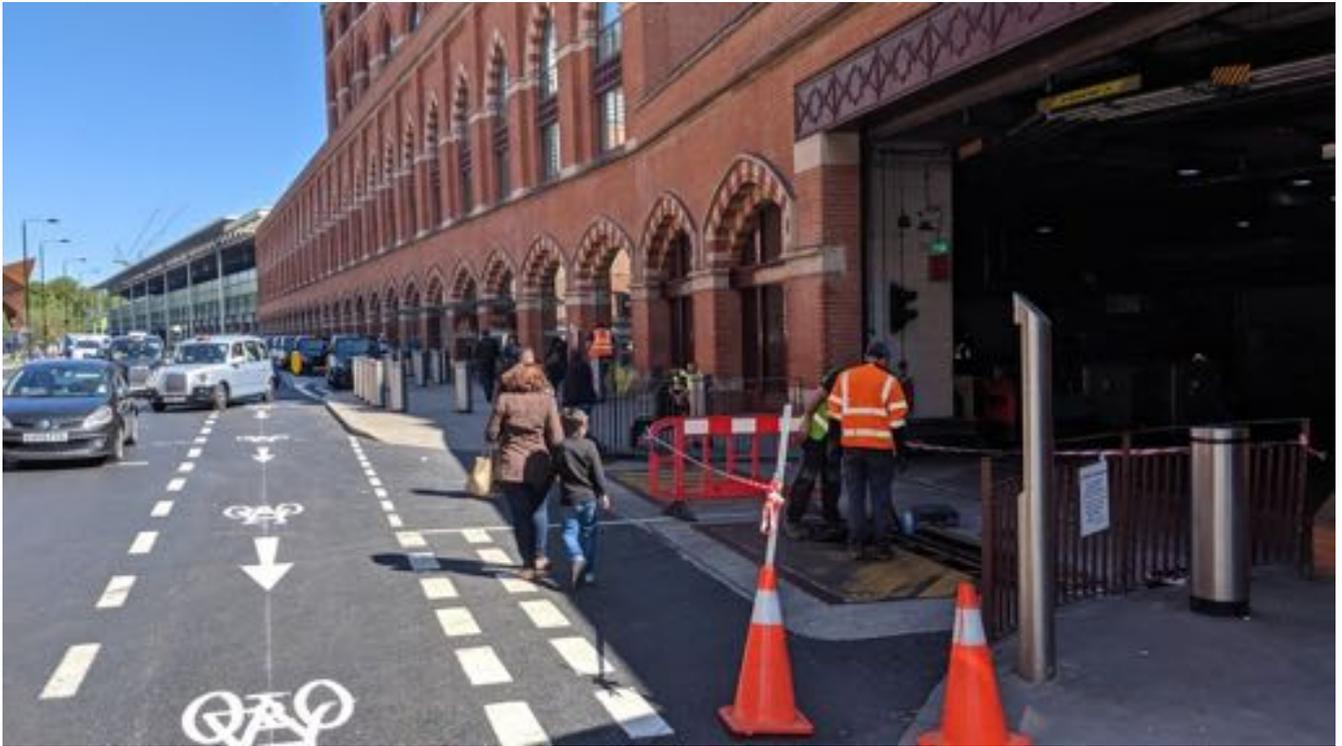
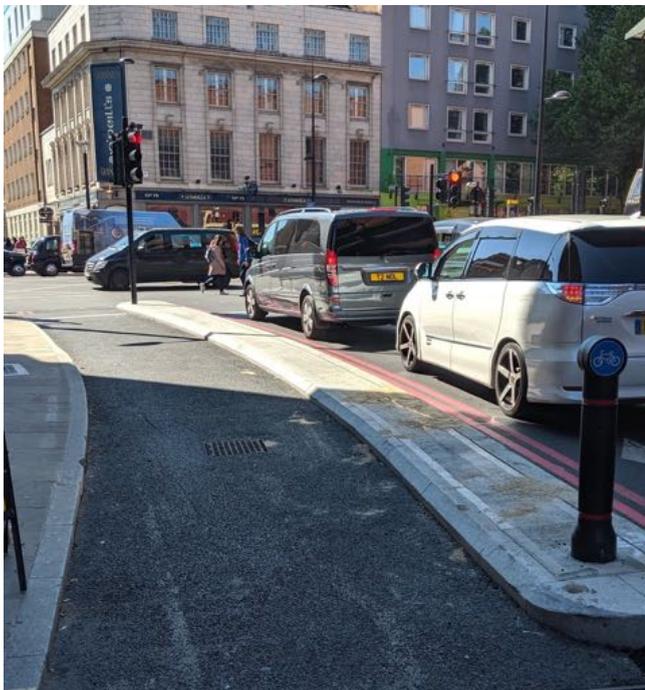
12. Goods entrance and exit

This seems to work reasonably well.

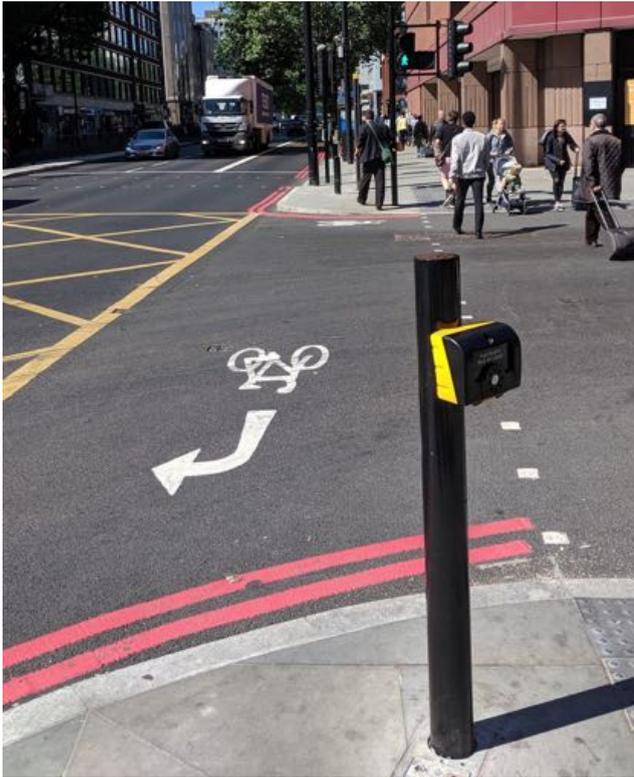
15. Two stage rights

The two-stage right turn pockets at the junction with Euston Road are well-positioned, being given 3m space and secondary signals.

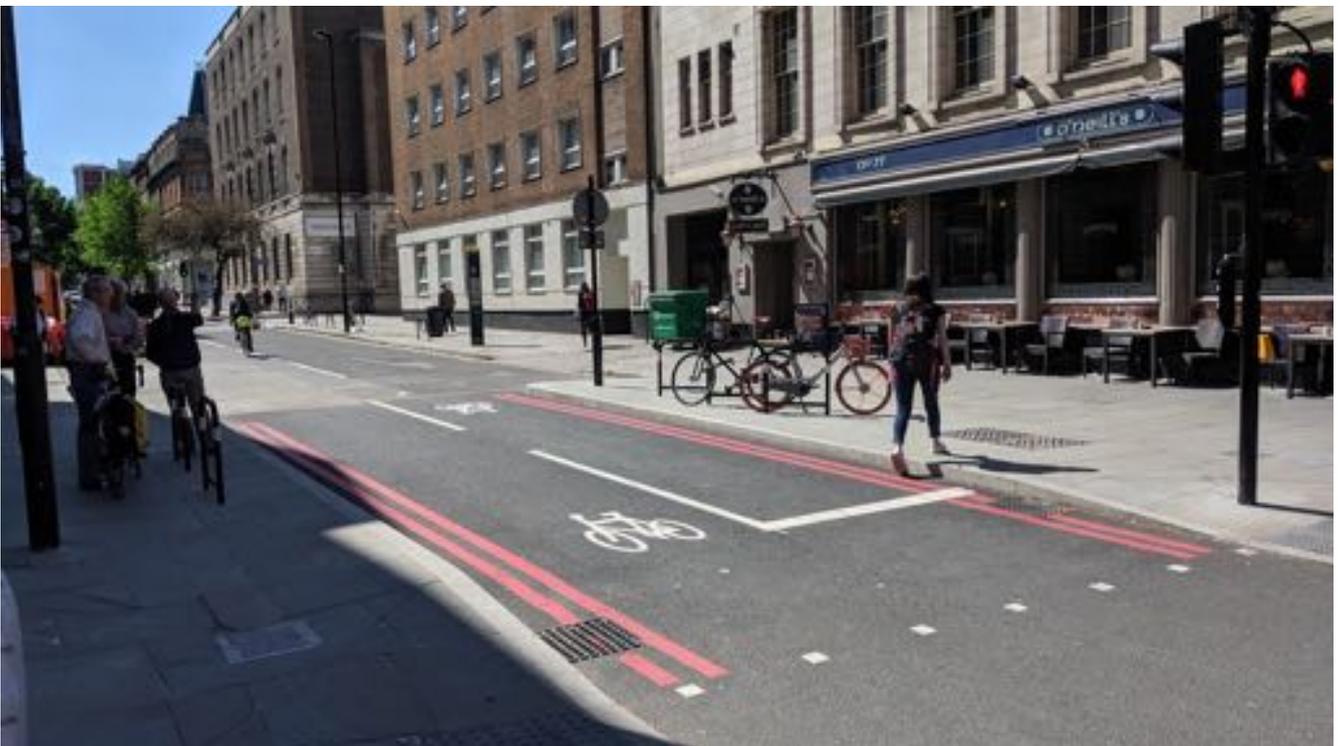
16. Top of Judd Street.

The cycle entry/exit section with footway build outs is attractive; the 'No Entry except cycles' signs seem to be effective.

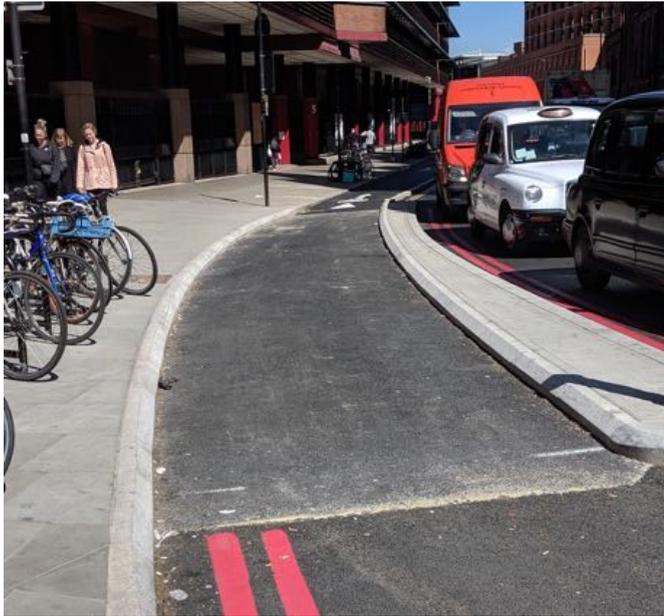
17. Entry to the contraflow on Midland Road

Cyclists approaching from Judd Street may fail to see the entry to the NB contraflow track on Midland Road because it is offset. The box junction markings prevent the use of elephants footprints. We suggest larger (and possibly two) blue cycle roundels (diagram 955) and an extra cycle logo at the entrance to the track.

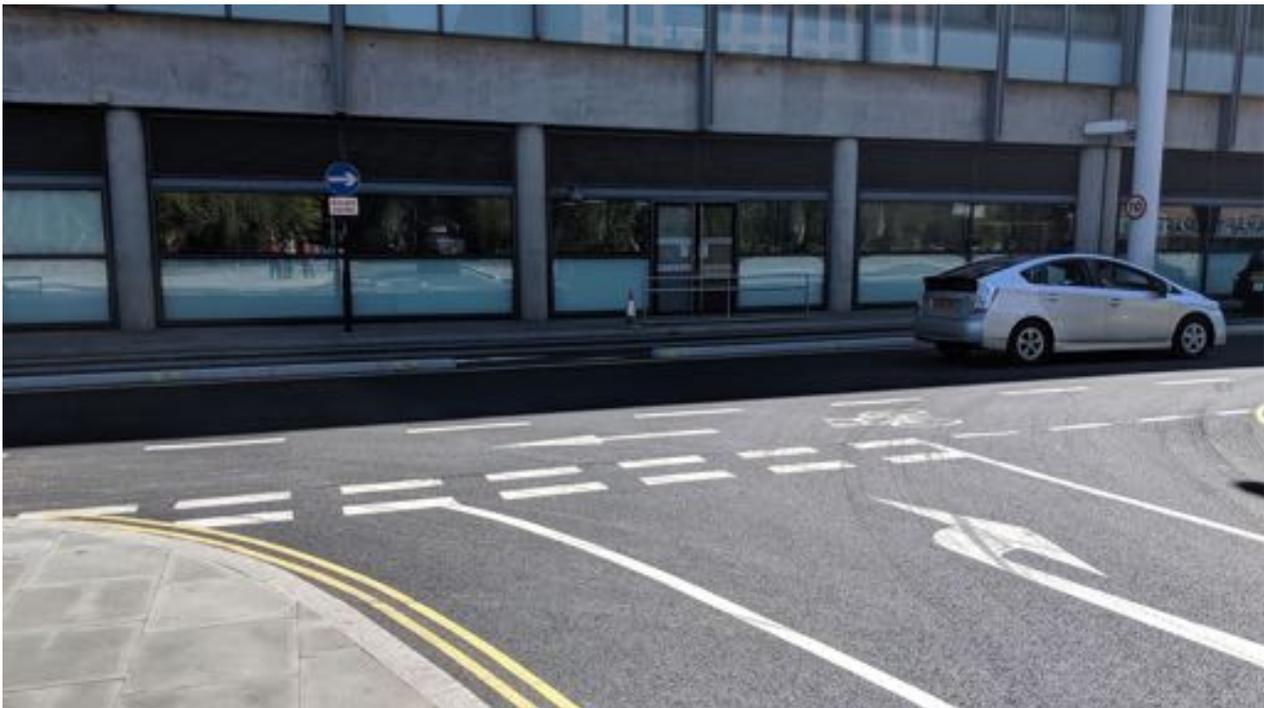
19. Exit for cycles from Brill Place

The markings seem to suggest cycles should turn left. Maybe a straight line?

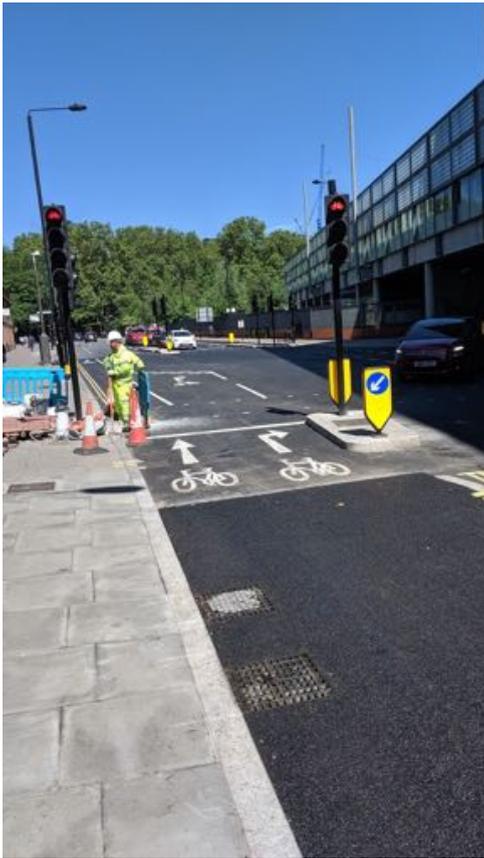
20. Junction for NB cycles on Midland Road at Pancras Road junction:

- The two-lane approach and right turn lane looks good
- Extra low-level cycle signals are definitely needed as the main signal head is not visible when a cyclist is stationary at the line.

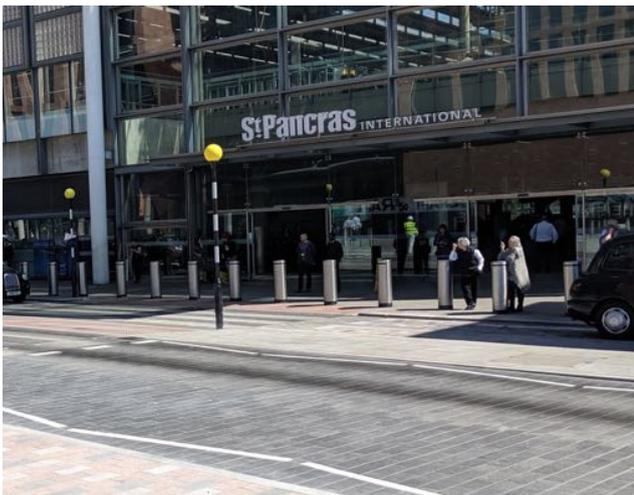
21. Signage for station users with cycles

Signage of the cycle route is needed for people with cycles emerging from the station (for people taking bikes on trains or leaving the cycle parking) and to the cycle parking for those wanting to use it.

- Visible to travellers emerging from the main entrance (photo on the left)
- Visible to people emerging from the coach exit.
